Asbestos Re-Inspection Report

Sioux Falls Federal Building/Courthouse
Sioux Falls, South Dakota
GSA Building No. SD0021

1/13-346-09.8005.0016

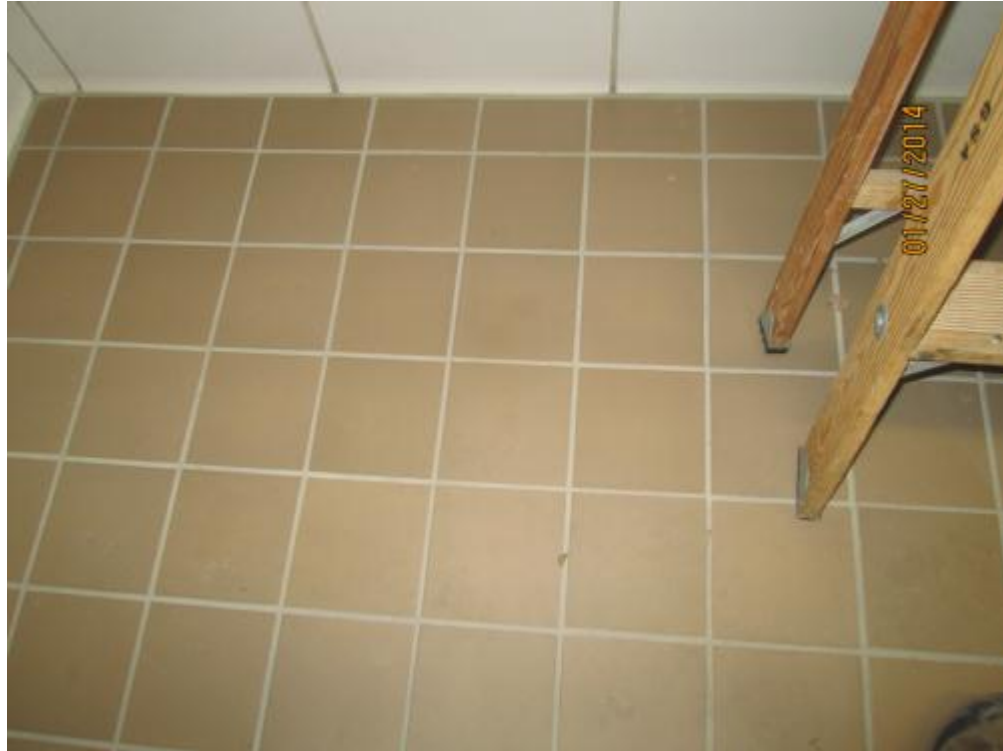
CTA01 –
Ceramic Tile
Adhesive –
under 5"x5" tan
tiles
(Assumed).

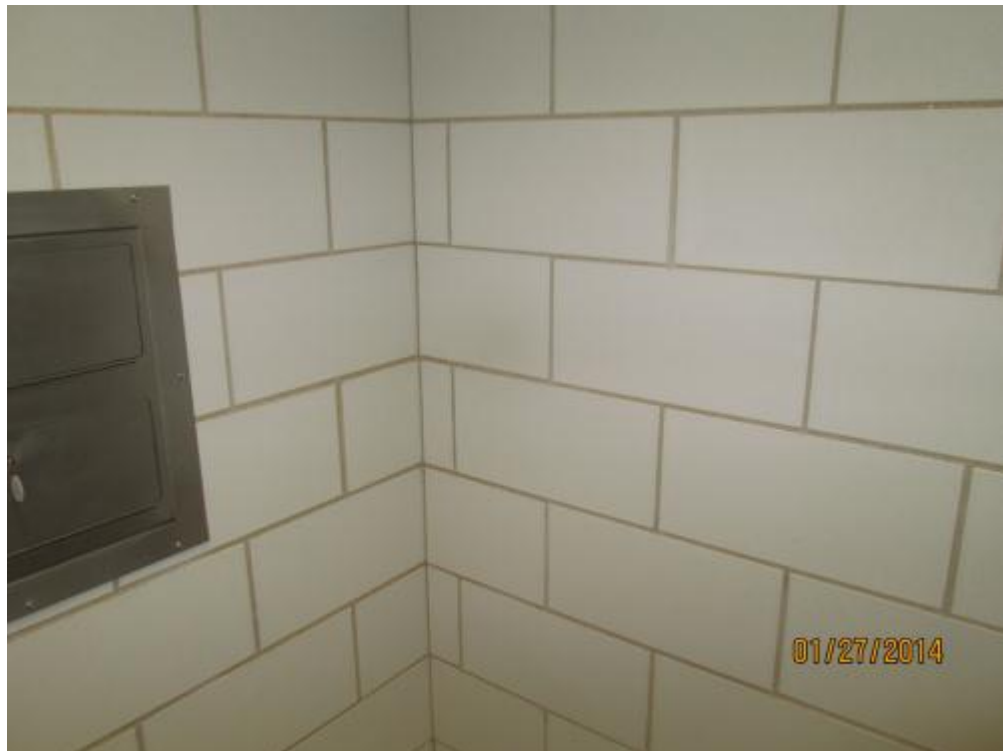
CTA02 –
Ceramic Tile
Adhesive –
under 6"x12"
white tile
(Assumed).

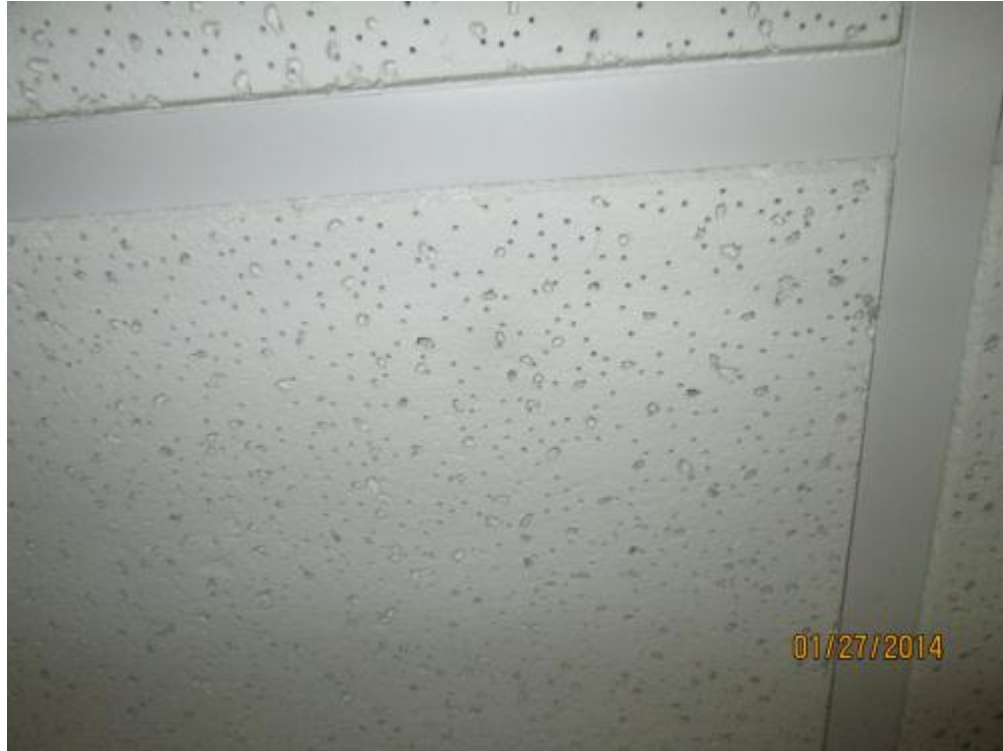
CT01 – Ceiling
Tile – 2'x2'
white with dots
and small
fissures (No
Asbestos
Detected).

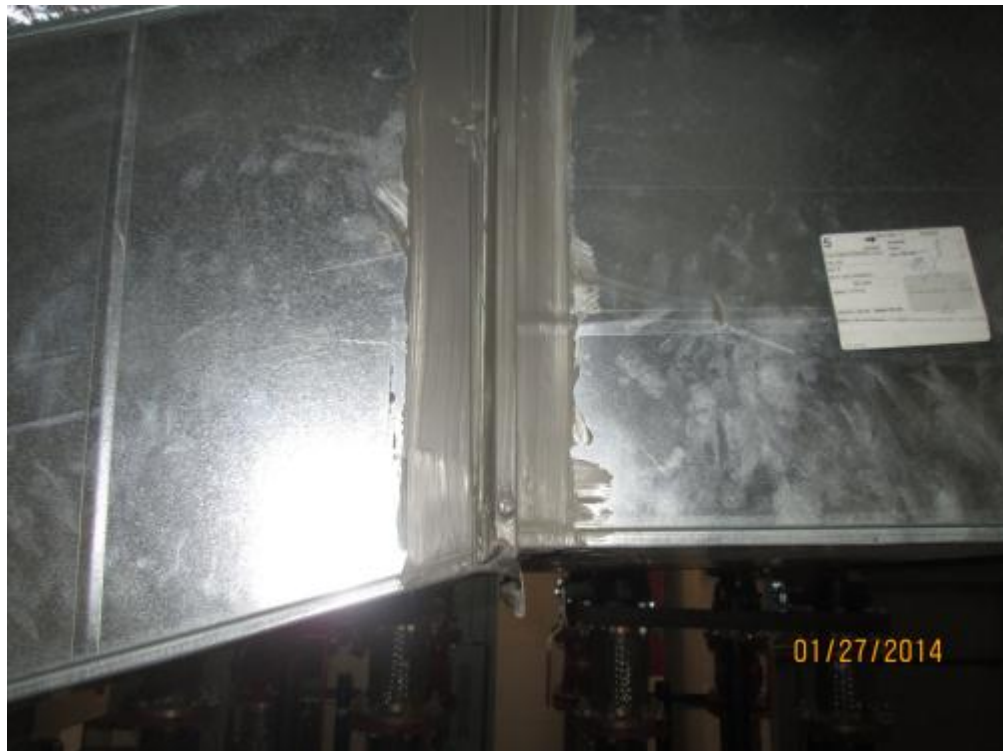
DTS01 – Duct
Sealant – gray
(No Asbestos
Detected).

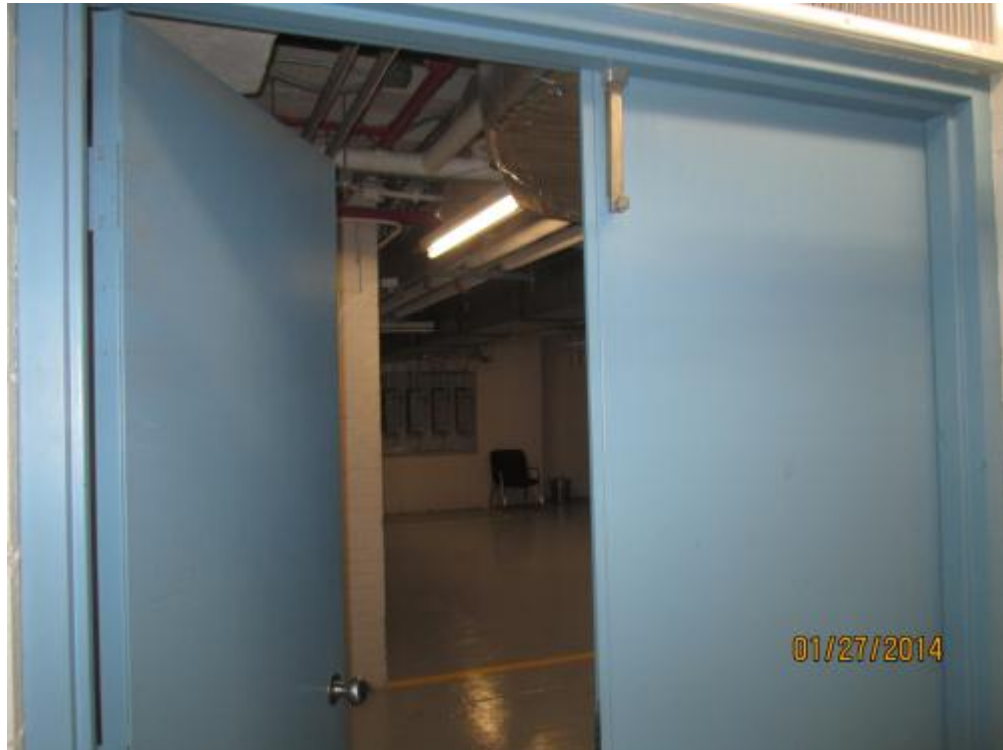
FDM01 – Fire Door Material – fireproofing within fire door (Assumed).

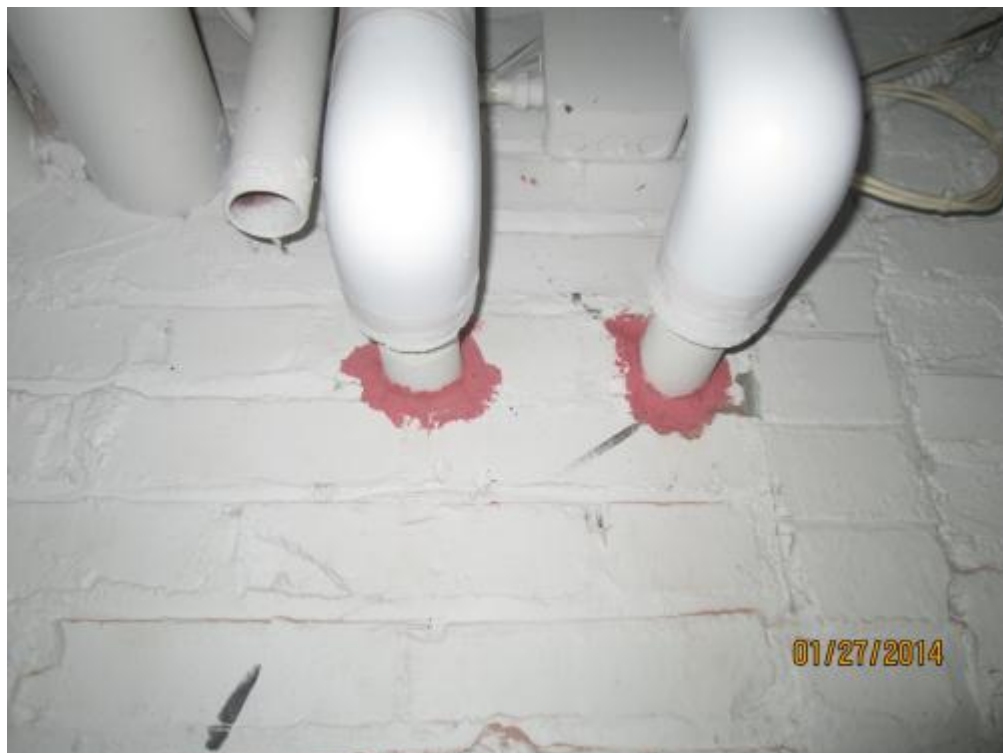
PPS01 – Pipe Penetration Sealant – pink (No Asbestos Detected).

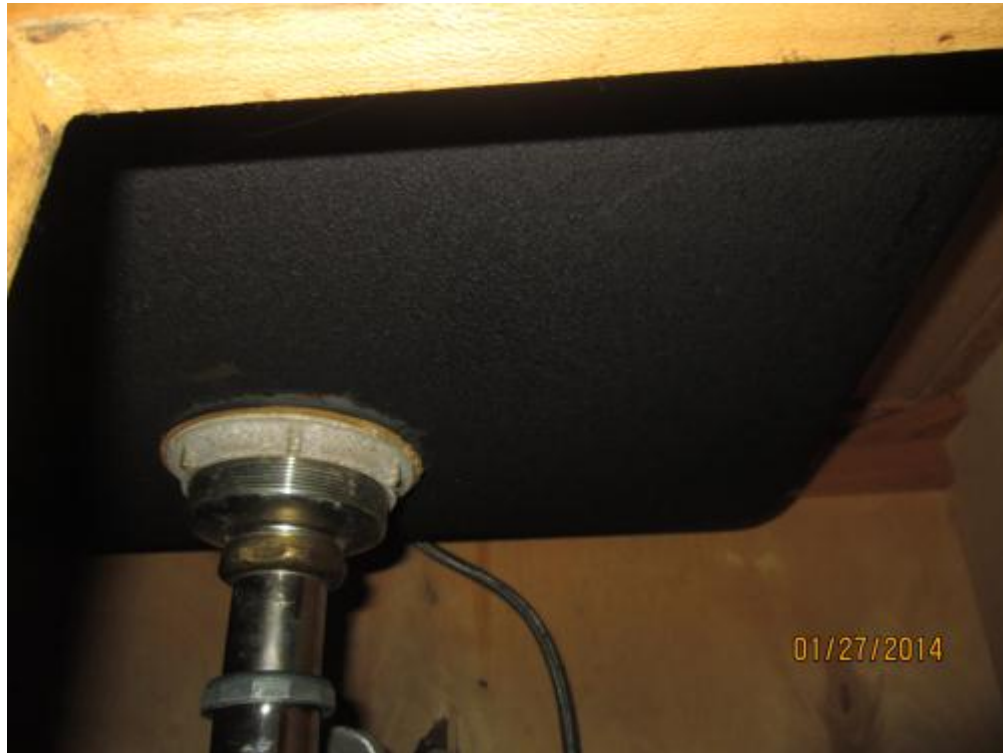
SUC02 – Sink
Undercoating –
black, rough (3%
Chrysotile).

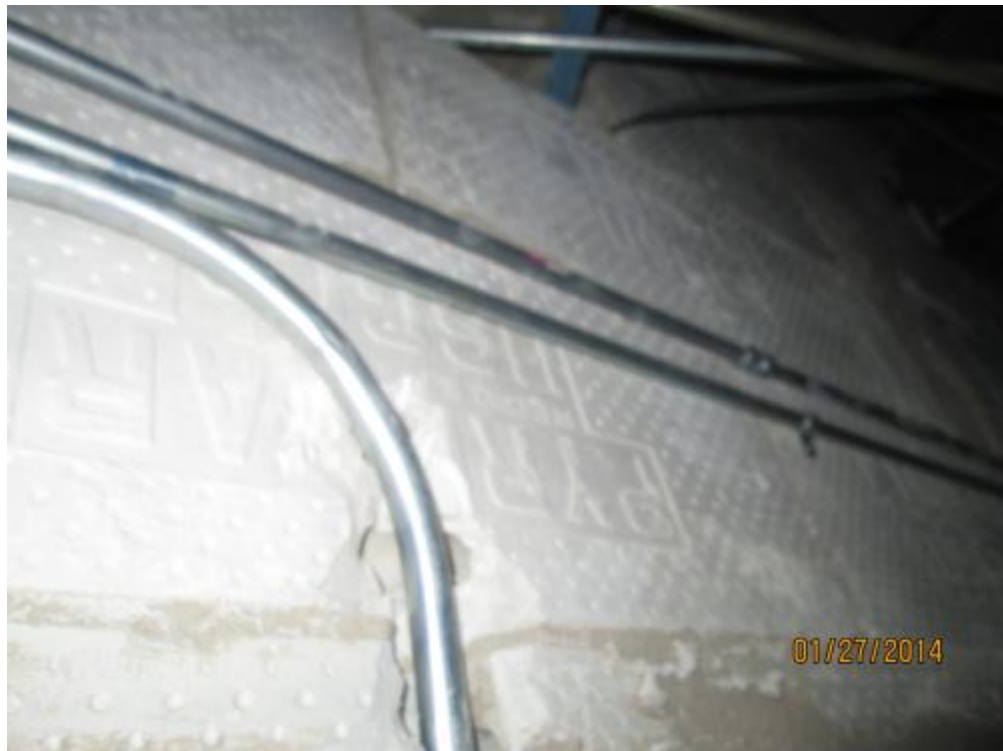
PL01 – Plaster –
white plaster
blocks (No
Asbestos
Detected).

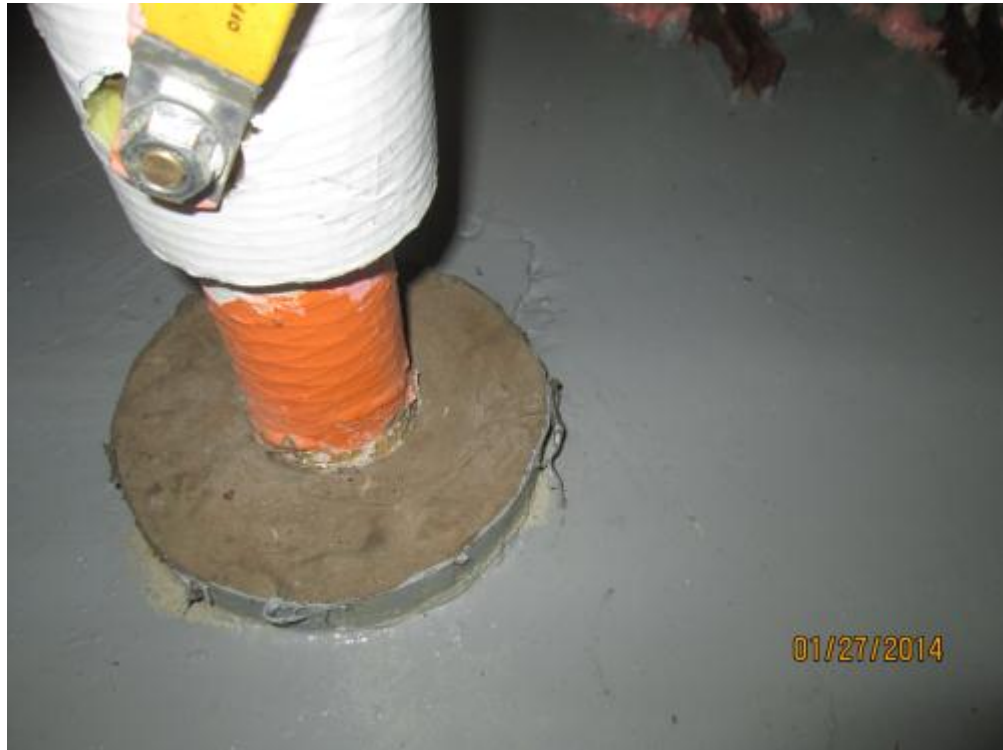
PPS02 – Pipe Penetration Sealant – light brown and painted green (No Asbestos Detected).

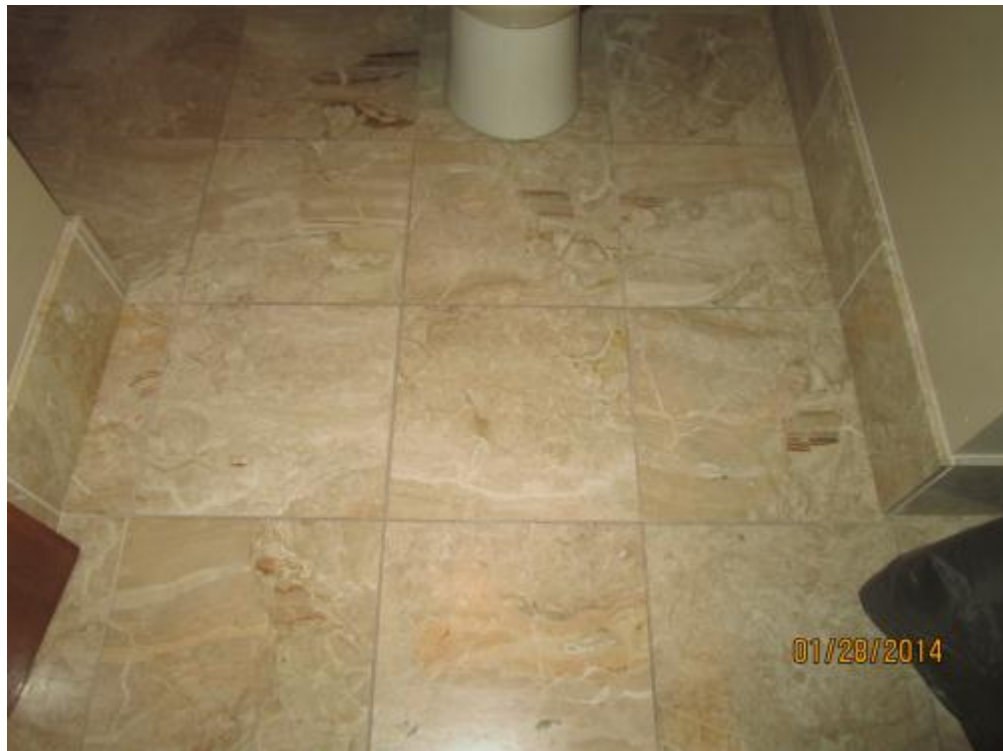
CTA04 – Ceramic Tile Adhesive – under tan marbled 12"x12" tile (**Assumed**).

Material Description	Material Number and Additional Comments	Management Recommendations
Ceramic Tile Adhesive	CTA04 – under tan marbled 12”x12” tile	O&M
