# Asbestos Sample Locations Laboratory Report

BUILDING 4, 1ST FLOOR  
 LAST UPDATED: 3-7-19

# XRF Lead-Based Report

**SCVAMC Building 4**  
**XRF Results**

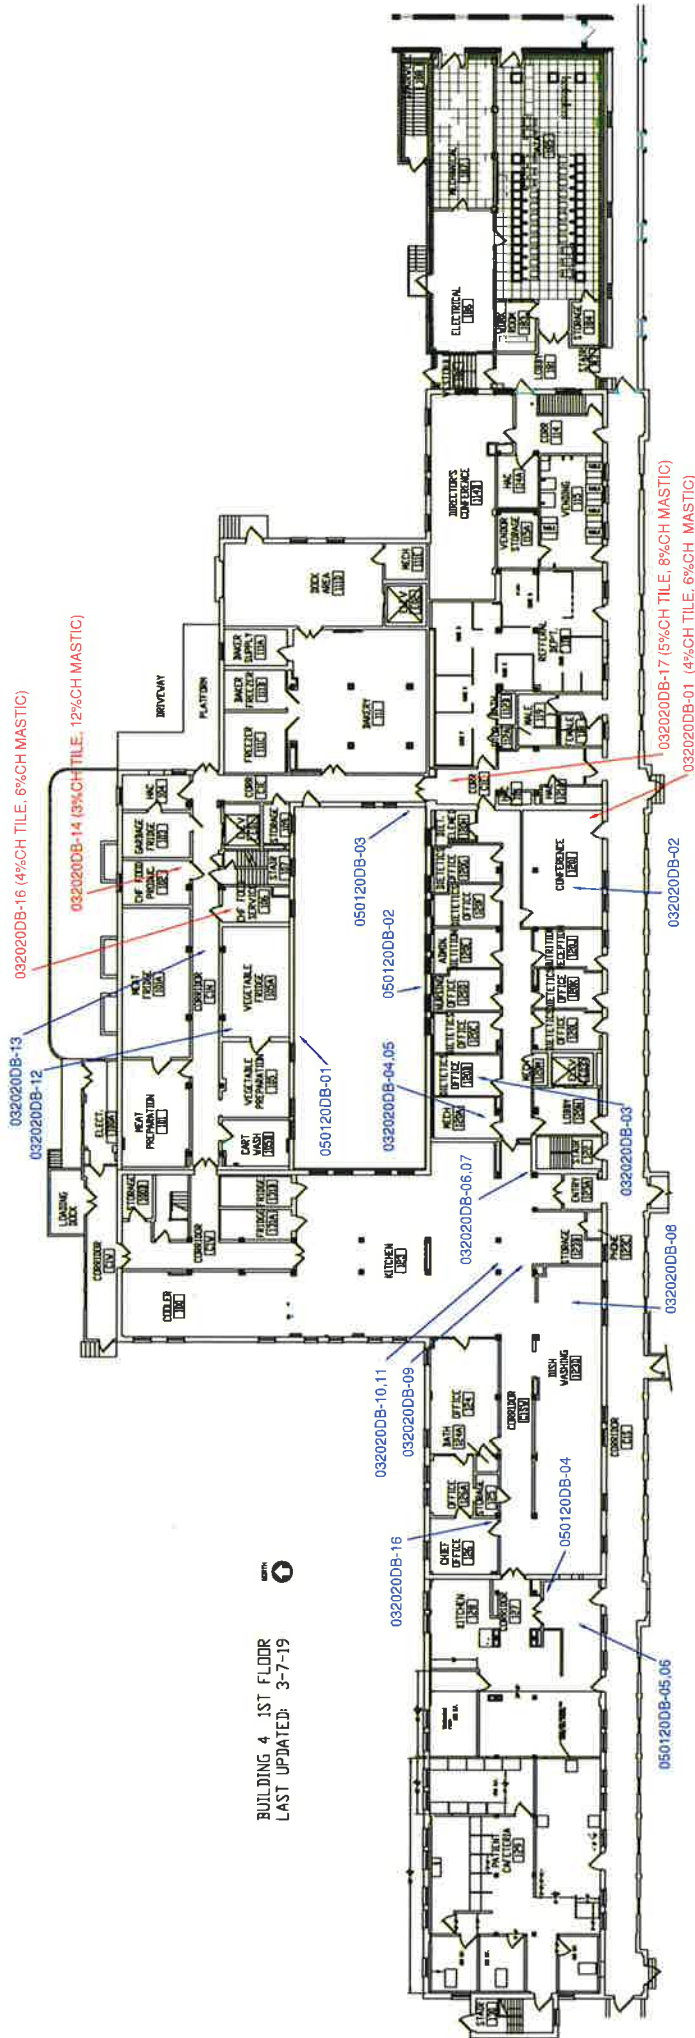
ASBESTOS SAMPLE LOCATION (POSITIVE)  
 ASBESTOS SAMPLE LOCATION (NEGATIVE)

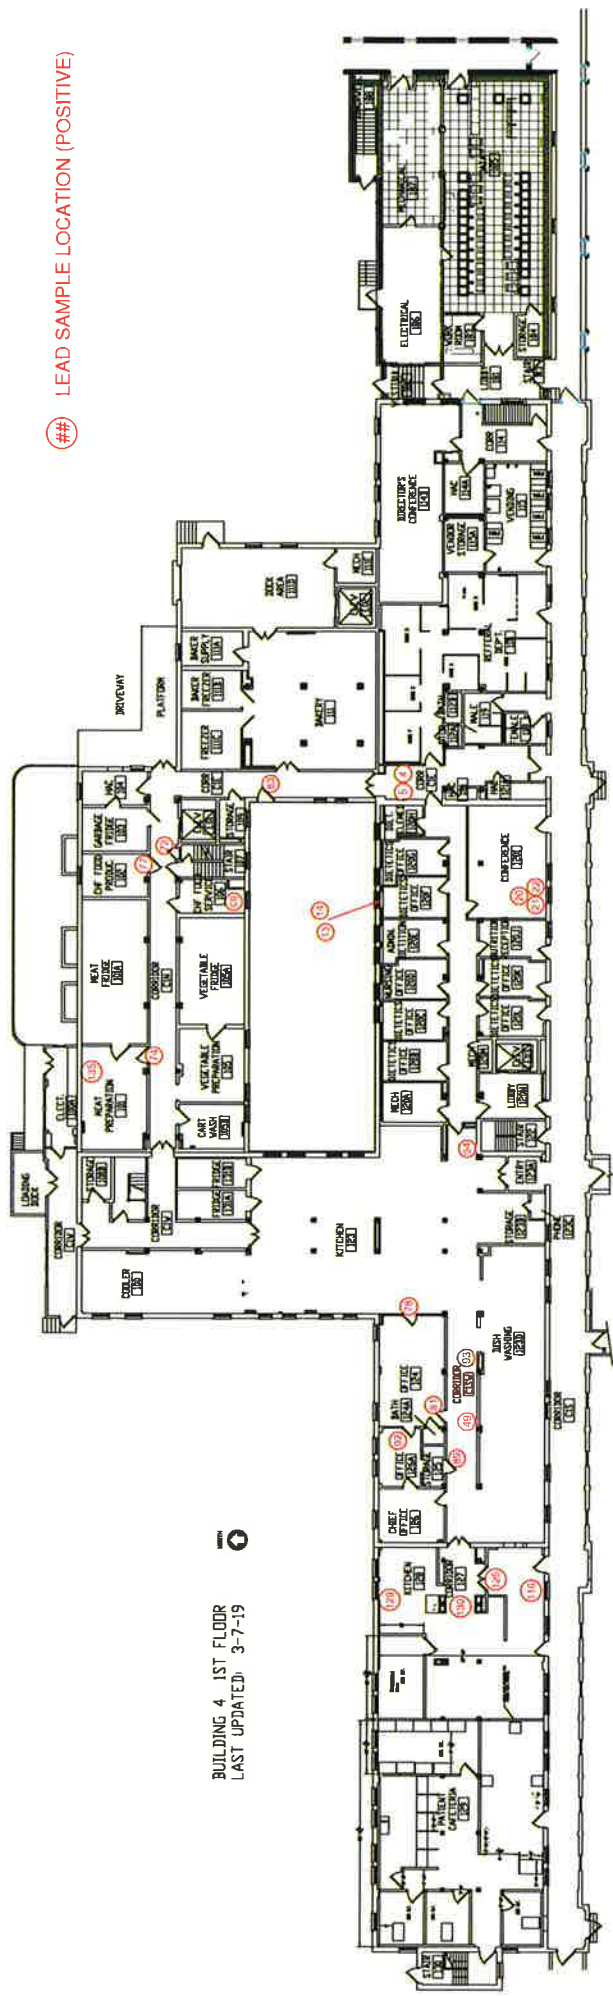
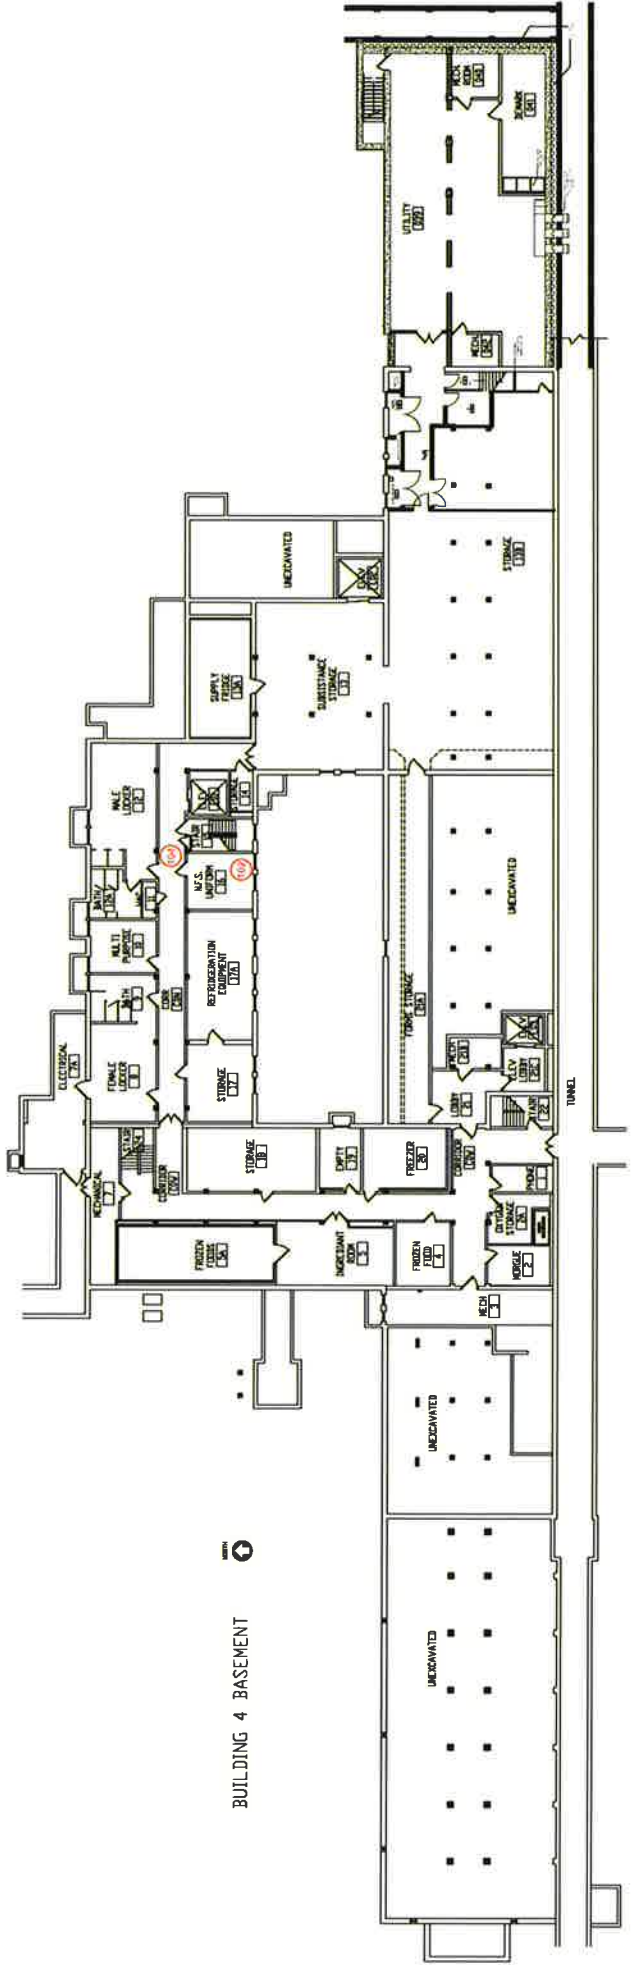
## LEAD SAMPLE LOCATION (POSITIVE)
