HAZARDOUS BUILDING MATERIALS INSPECTION REPORT

Sioux Falls VA Medical Center

**New SPS Addition
Sioux Falls, South Dakota**

VA Project No: 438-460

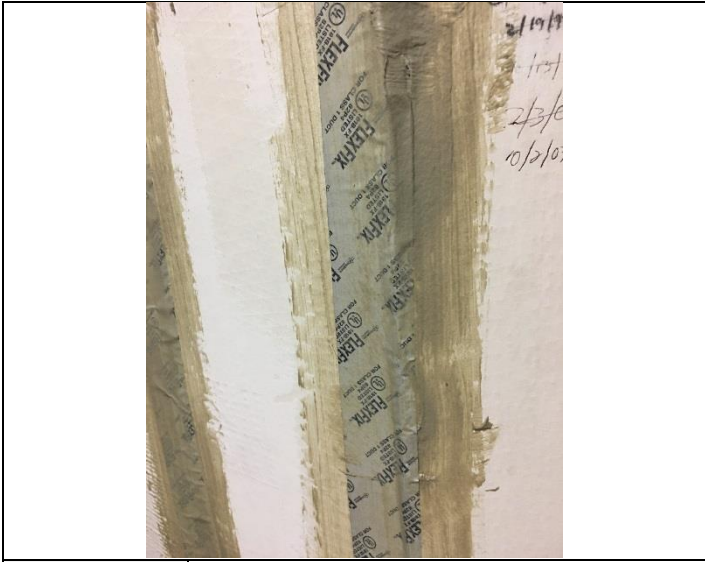
PHOTO 1 | Gray Mastic – Duct in below grade mechanical room

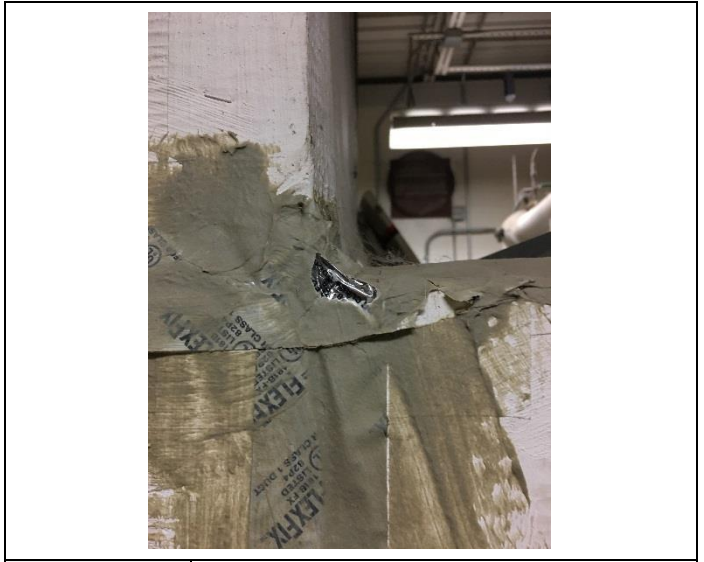
PHOTO 2 | Gray Mastic – Duct in below grade mechanical room

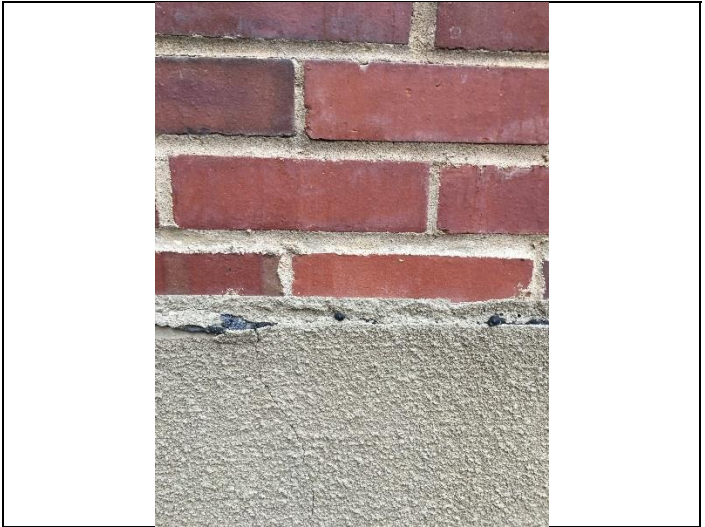
PHOTO 3 | EFIS Surfacing – Mech. Room & Entry Area

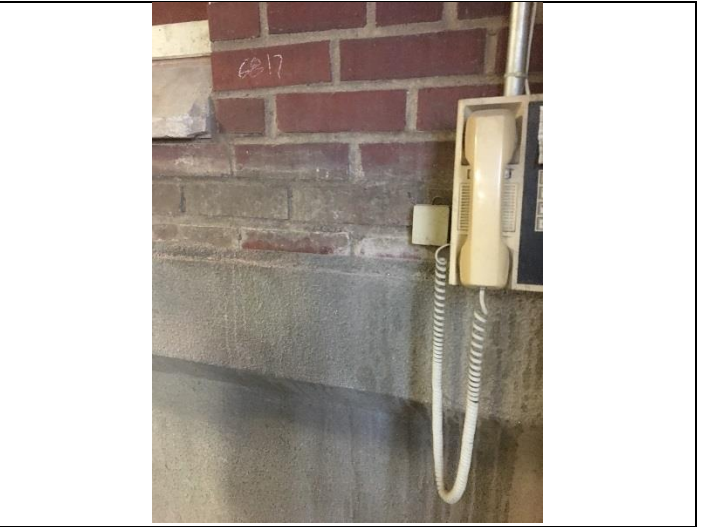
PHOTO 4 | EFIS Surfacing – Mech. Room & Entry Area

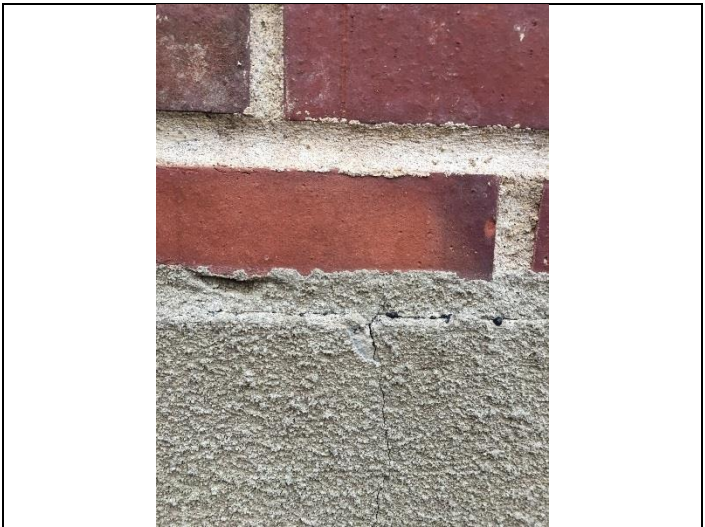
PHOTO 5 | EFIS Surfacing – Mech. Room & Entry Area

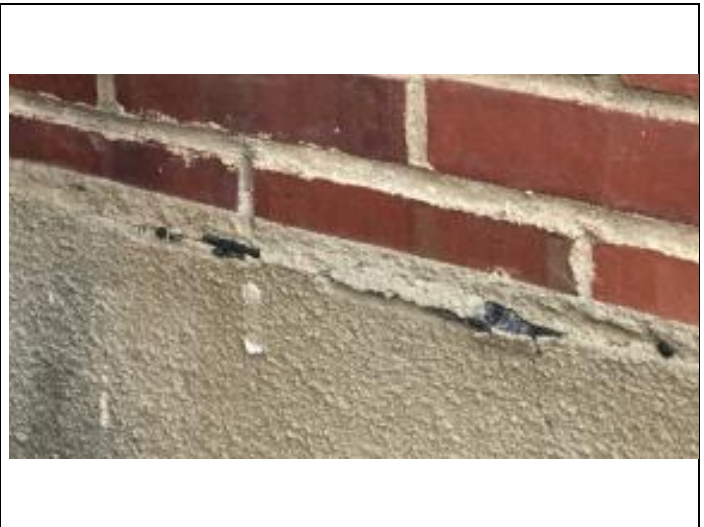
PHOTO 6 | Black Tar Under EFIS – Mech. Room Entry

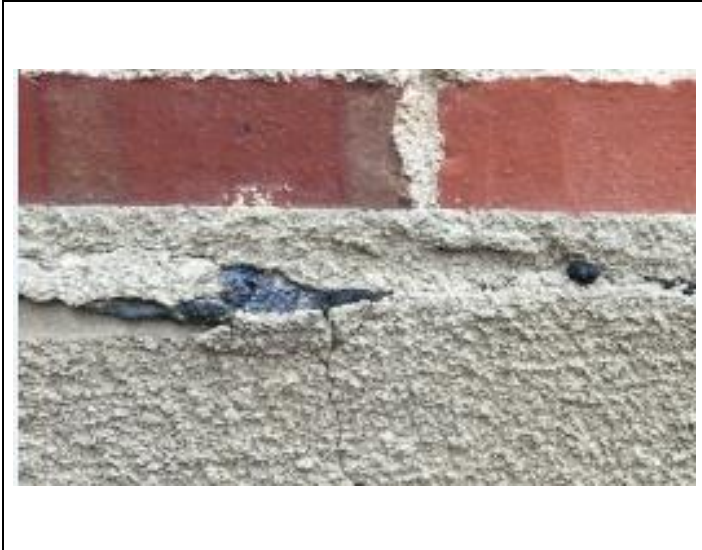
PHOTO 7 Black Tar Under EFIS – Mech. Room Entry

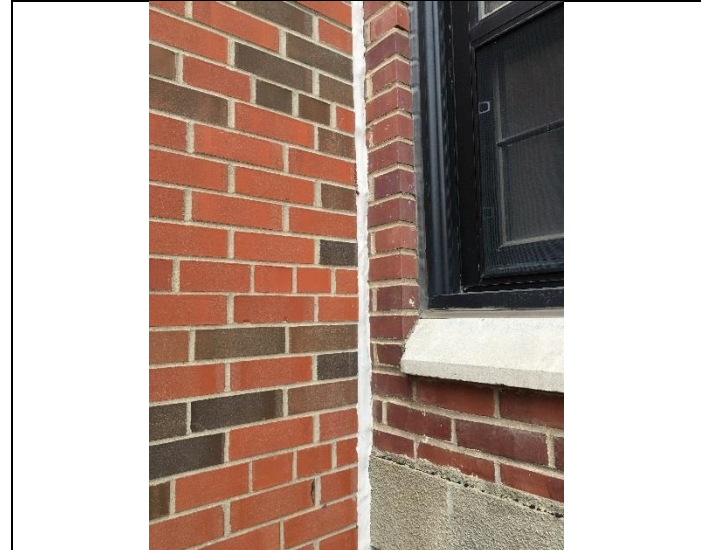
PHOTO 8 White Joint Caulk – Entry to Mech. Room

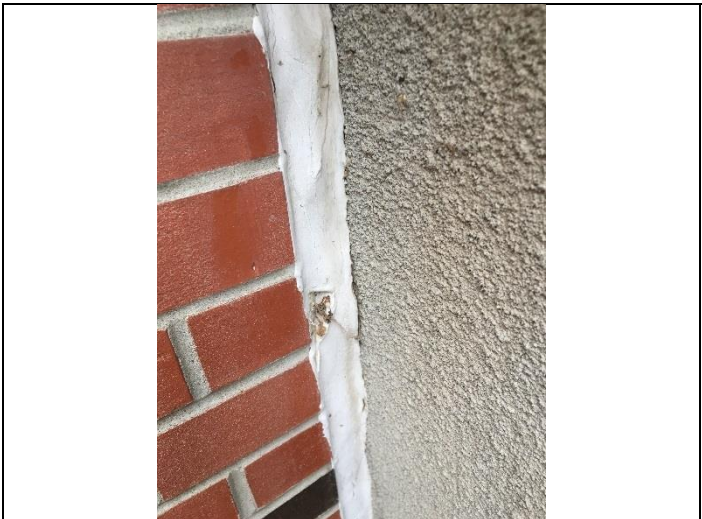
PHOTO 9 White Joint Caulk – Entry to Mech. Room

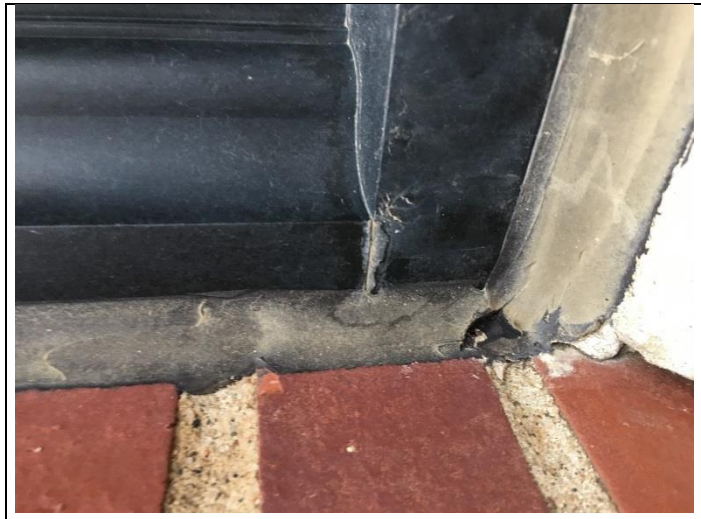
PHOTO 10 Gray Window Caulk - Exterior

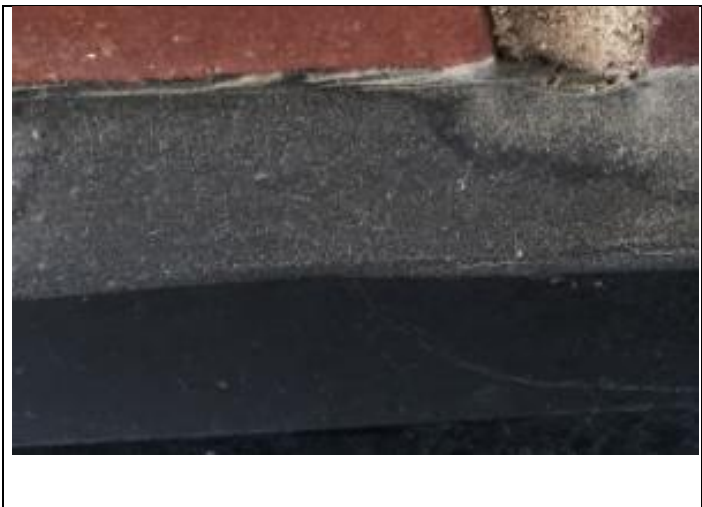
PHOTO 11 Gray Window Caulk - Exterior

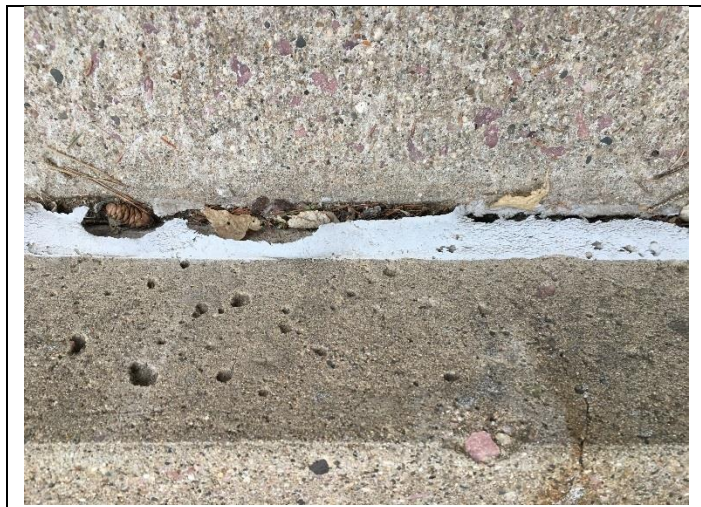
PHOTO 12 Gray Joint Caulk – Horizontal Concrete Pad

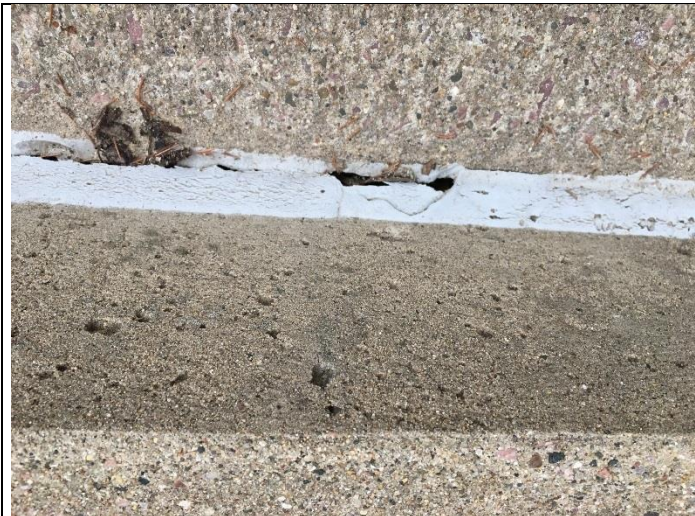
PHOTO 13 Gray Joint Caulk – Horizontal Concrete Pad

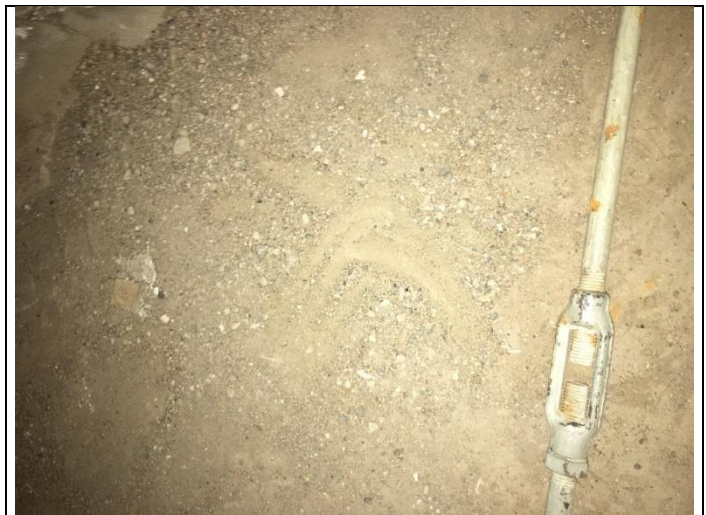
PHOTO 16 Debris on Tunnel Floor

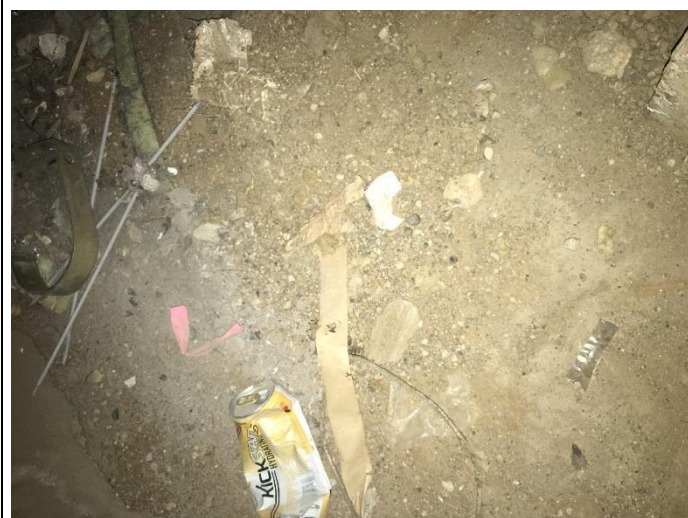
PHOTO 17 Debris on Tunnel Floor

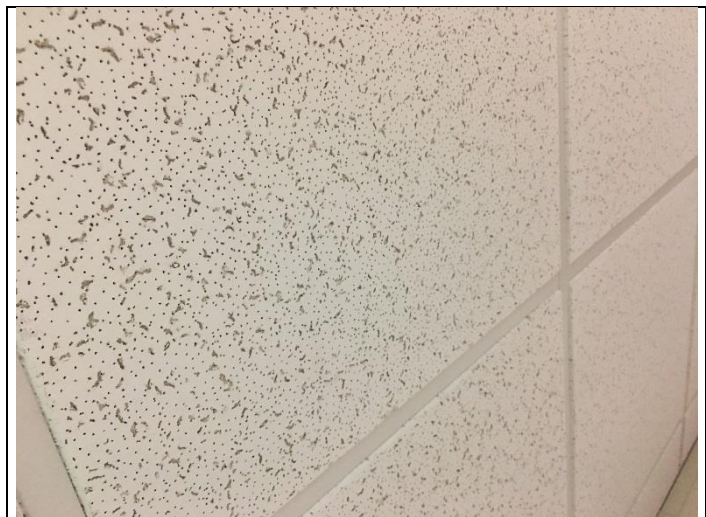
PHOTO 18 2' x 2' Ceiling Tile D-17

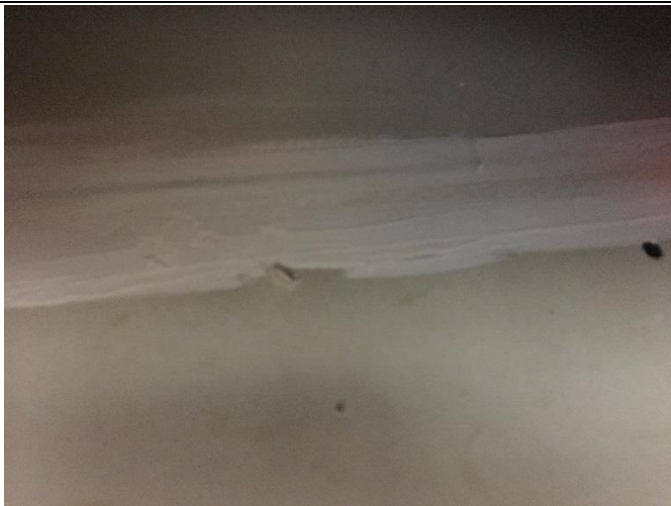
PHOTO 21 | Drywall/Joint Compound D-17

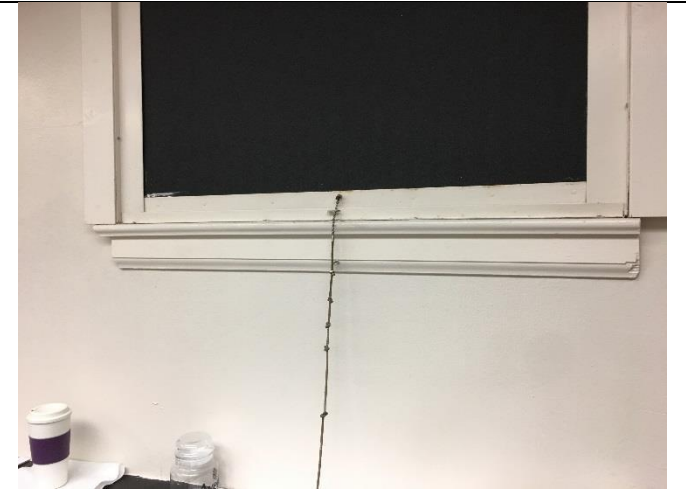
PHOTO 22 | Black Window Caulk – Windows Throughout

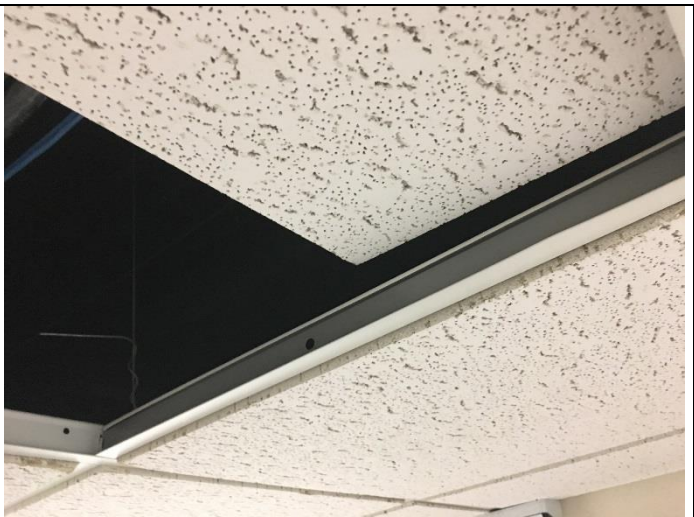
PHOTO 24 | 2' x 2' Ceiling Tile Hallway

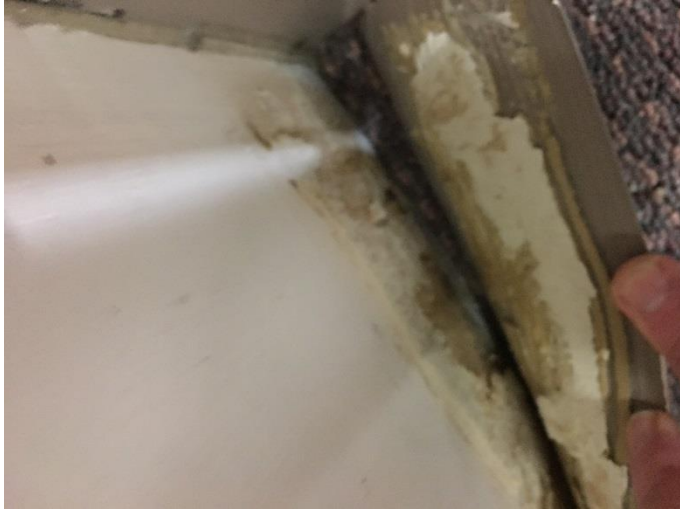
PHOTO 25 | Tan Base Cove Mastic

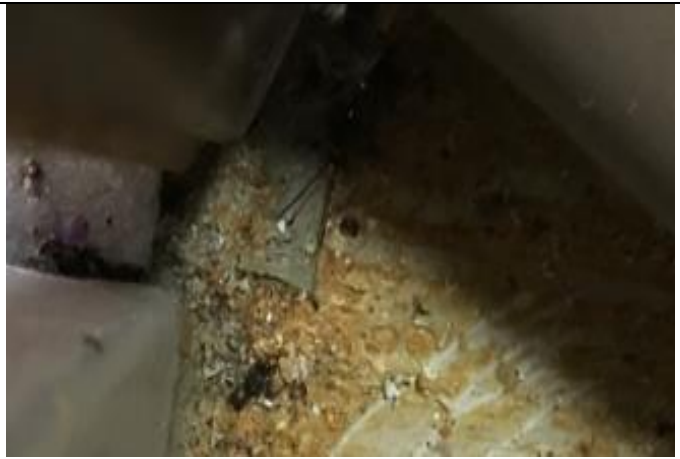
PHOTO 27 | Brown Carpet Mastic – D 21

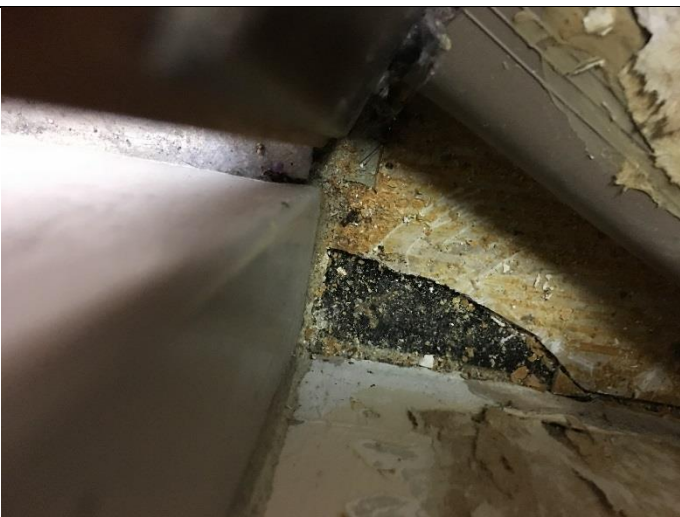
PHOTO 29 | Beige VFT Black Mastic (under carpet) – D 21

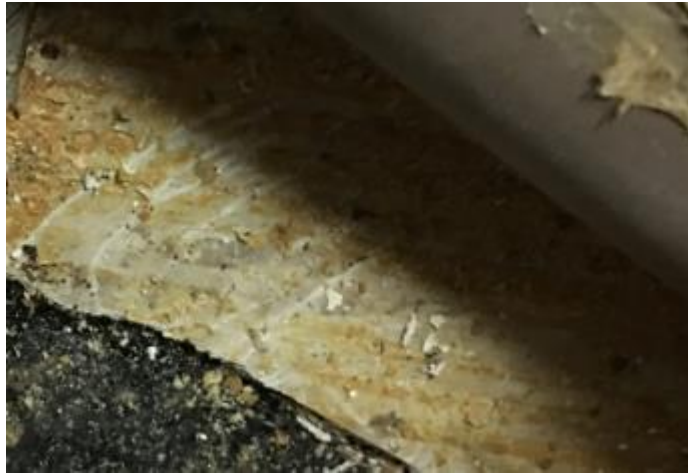
PHOTO 31 Beige VFT Black Mastic (under carpet) – D 21

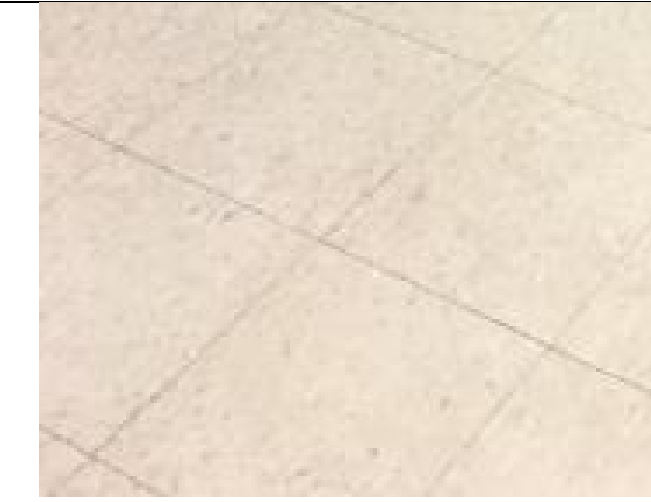
PHOTO 33 12" x 12" Beige VFT – D-27 (throughout space)

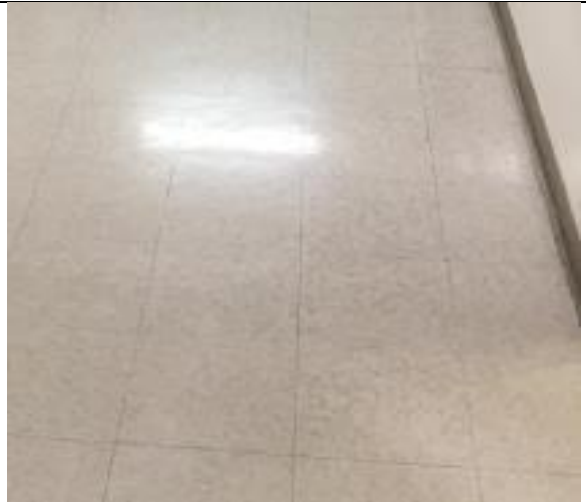
PHOTO 34 12" x 12" Beige VFT – D-27 (throughout space)

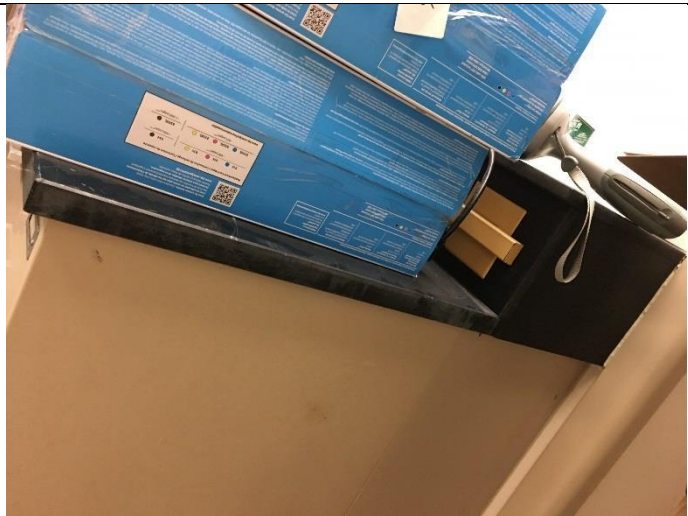
PHOTO 35 Epoxy Resin Bench Top - Lab

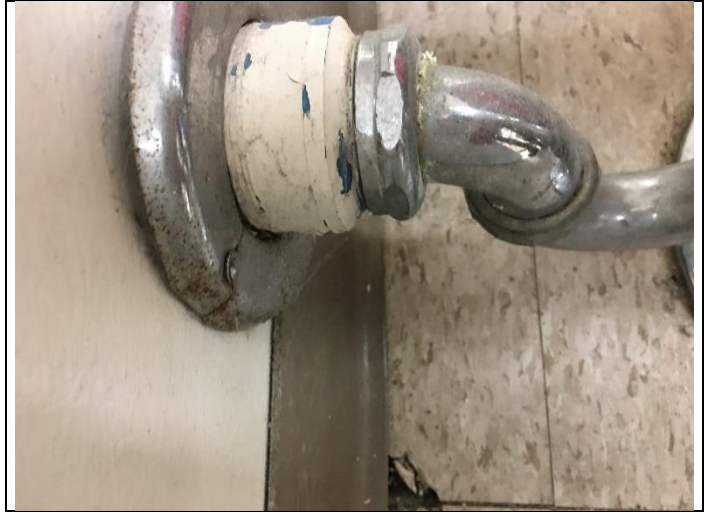
- Black mastic under 12” x 12” VFT patched area in main lab (50 ft²)
The VFT is considered ACM since it is associated with the black mastic present on the underside of the VFT applications. Both VFT and Black Mastic are considered ACM.-
- Black mastic in Rm D20 (Mechanical Room) Not associated with VFT. (44 ft²)

PHOTO 40 12" x 12" VFT Tan Blotchy/Mastic
Black Mastic 4% Chrysotile

State and/or federal regulations require that ACMs be removed prior to demolition or renovation activities that will impact the ACMs. Depending on the specific renovation work to be performed, certain ACMs may not require removal if they will not be disturbed and do not pose a risk to building occupants or construction trade workers. However, to ensure worker safety and to eliminate future asbestos-related maintenance and management costs and risks, AMIE recommends removal of all identified ACMs in the areas to be renovated. While partial abatement may be technically possible, it is often impractical and not cost-effective.

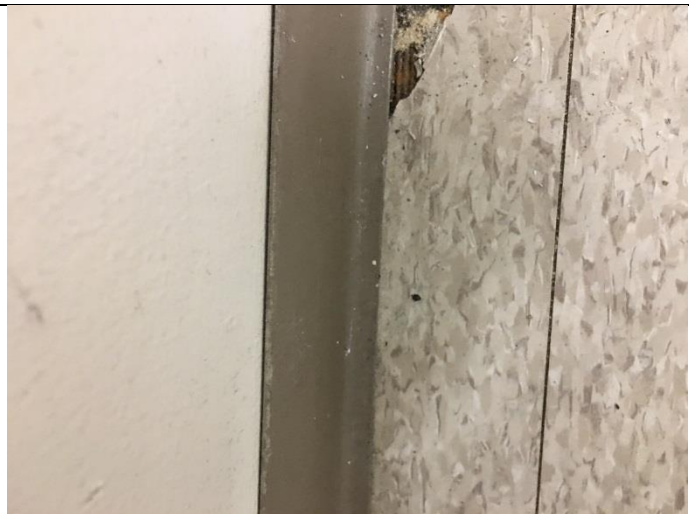
PHOTO 41 12" x 12" VFT Tan Blotchy/Mastic
Black Mastic 4% Chrysotile

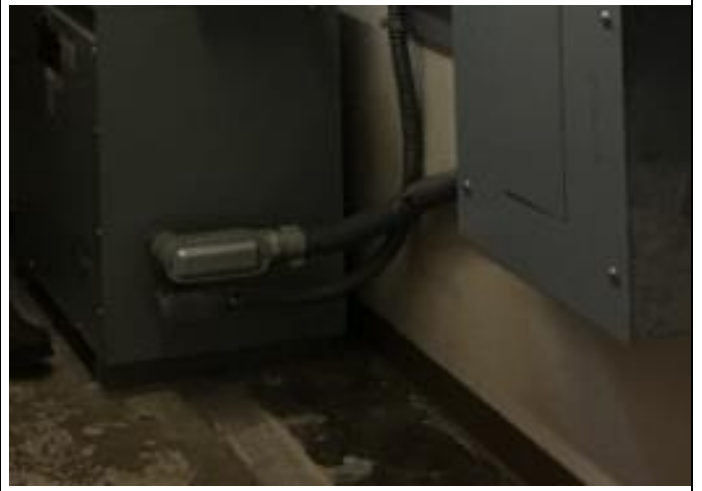
PHOTO 44 Black Mastic – D-20
5% Chrysotile

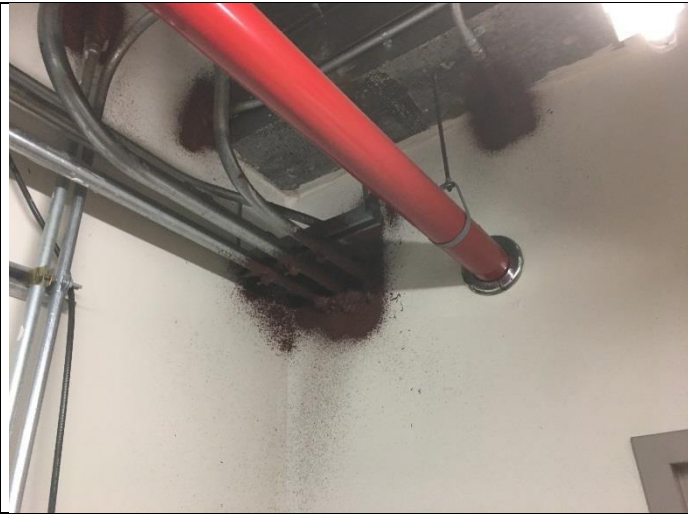
PHOTO 45 Firestop – D-20

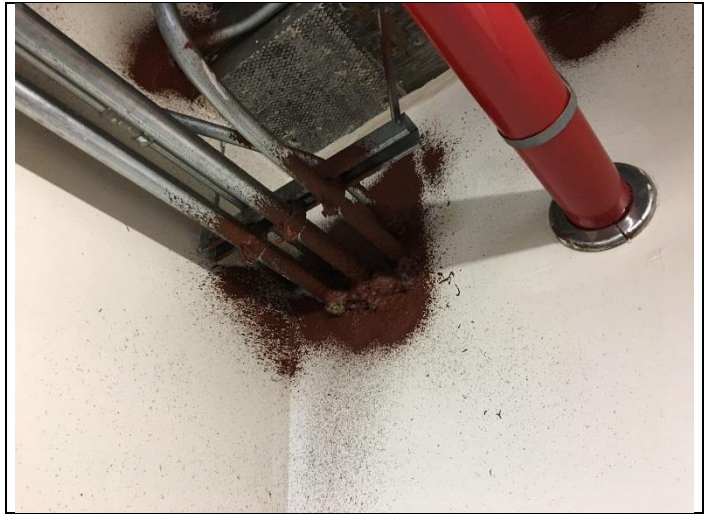
PHOTO 46 Firestop – D-20

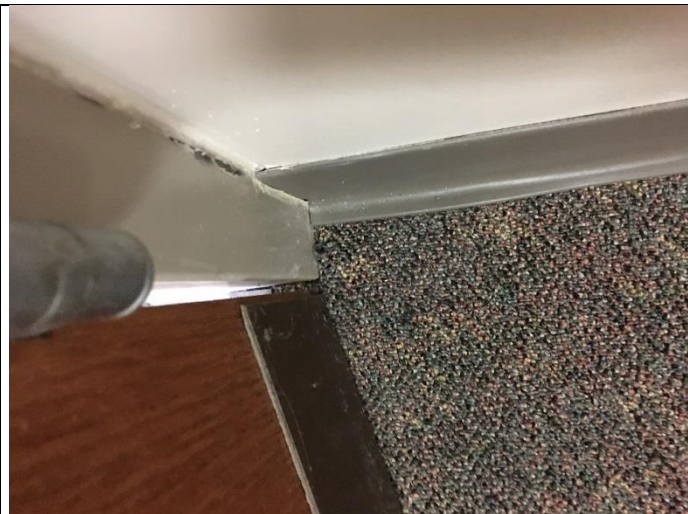
PHOTO 47 12" x 12" VFT Tan/Black Mastic
Under Carpet D-22

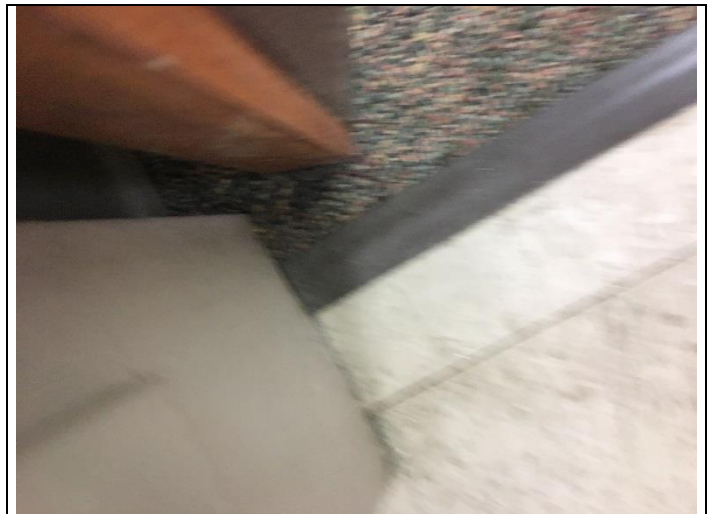
PHOTO 48 12" x 12" VFT Tan/Black Mastic
Under Carpet D-22

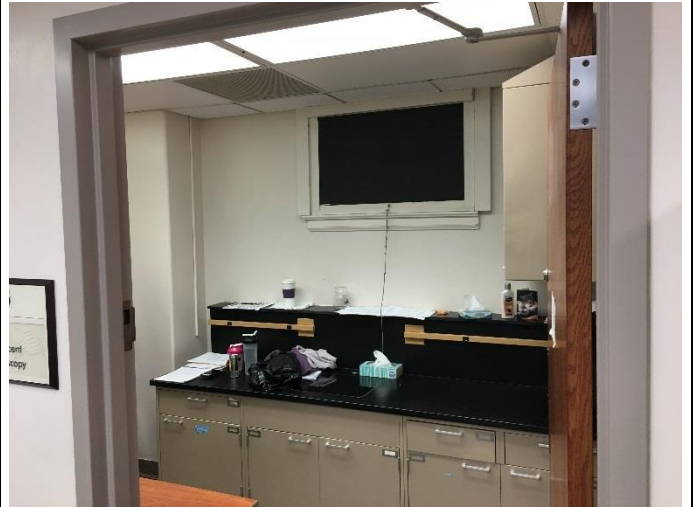
PHOTO 50

Black Epoxy Resin Bench Top – D-25

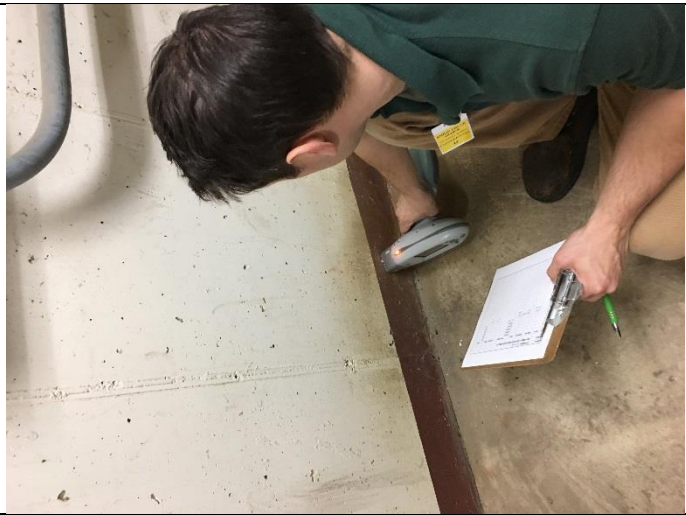
PHOTO 3 Red Base Cove Paint – Below Grade Mech. Room
<1mg/cm² lead

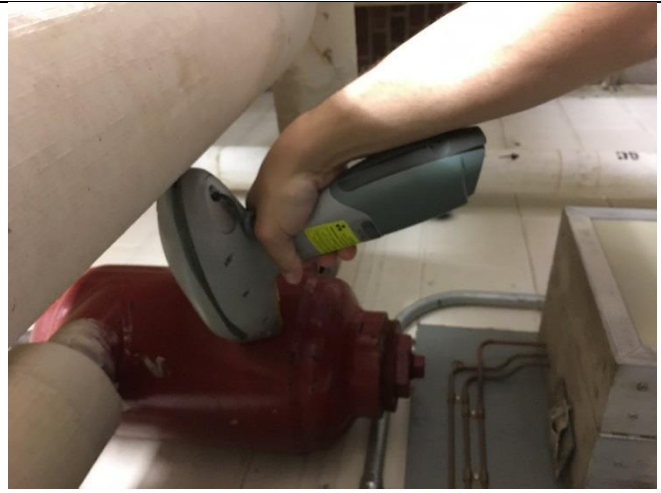
PHOTO 8 Red Painted Mixing Chamber – Below Grade Mech. Room
<math><1\text{mg}/\text{cm}^2</math> lead

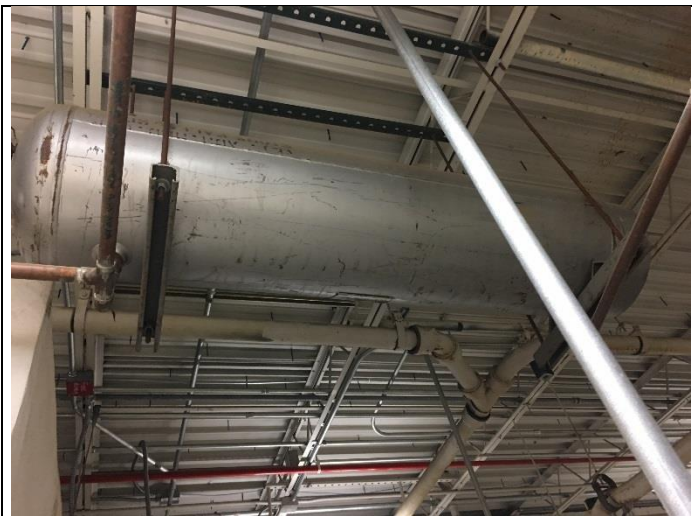
PHOTO 18 Silver Overhead Tank – Below Grade Mech. Room
<math><1\text{mg}/\text{cm}^2\text{ lead}</math>

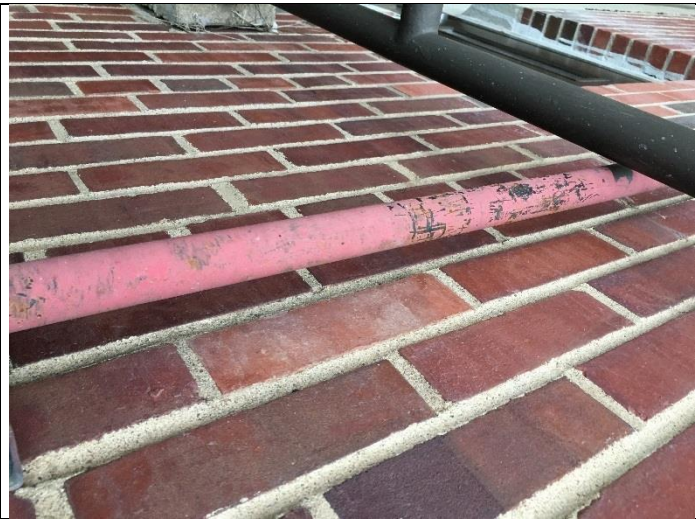
PHOTO 25 Red Pipe - Exterior
<1mg/cm² lead

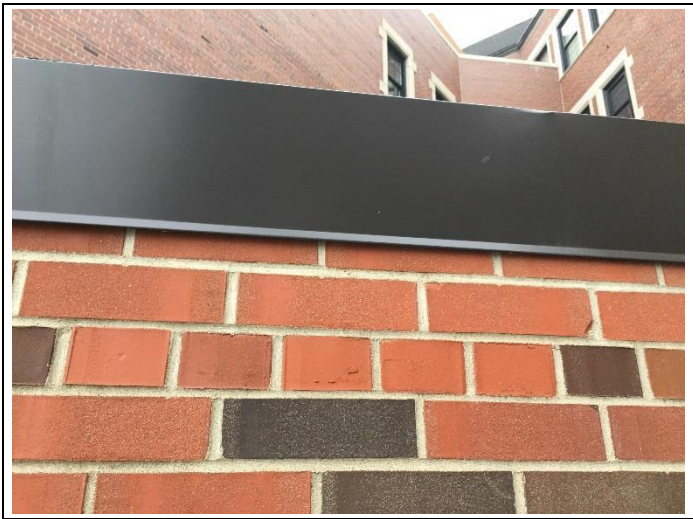
PHOTO 26 Black Flashing - Exterior
<1mg/cm² lead

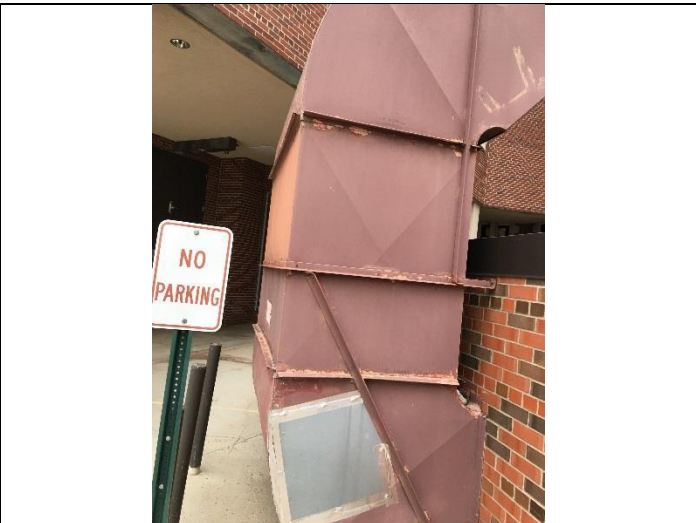
PHOTO 27 Red Ventilation Duct - Exterior
<1mg/cm² lead

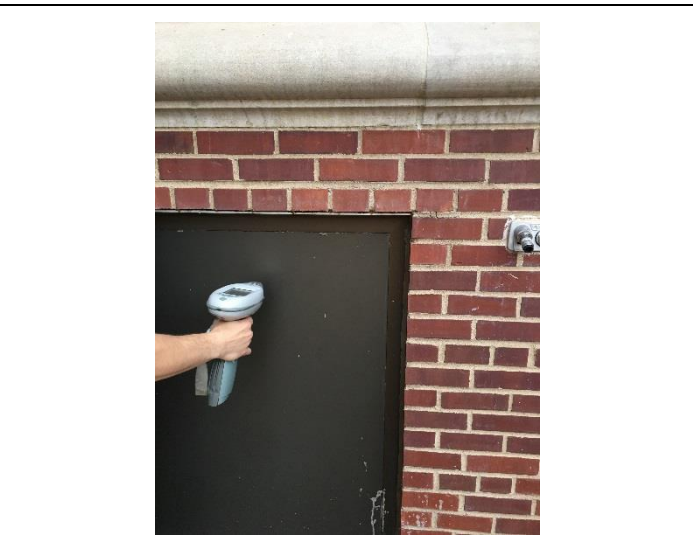
PHOTO 30 Brown Door - Exterior
<1mg/cm² lead

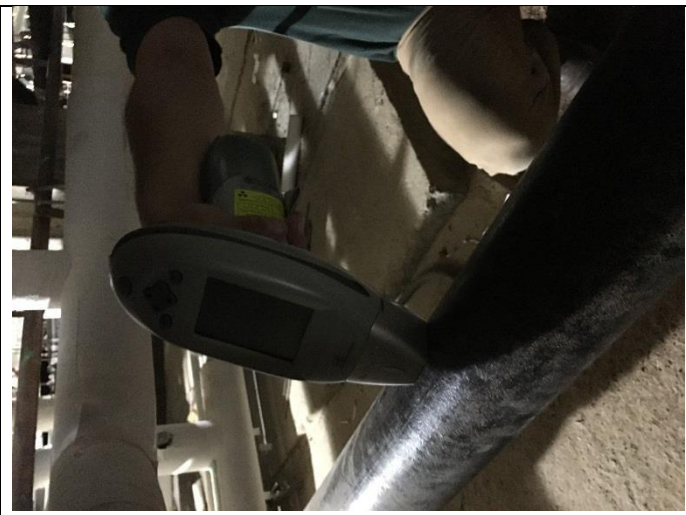
PHOTO 33 Black Pipe – Tunnel
<1mg/cm² lead

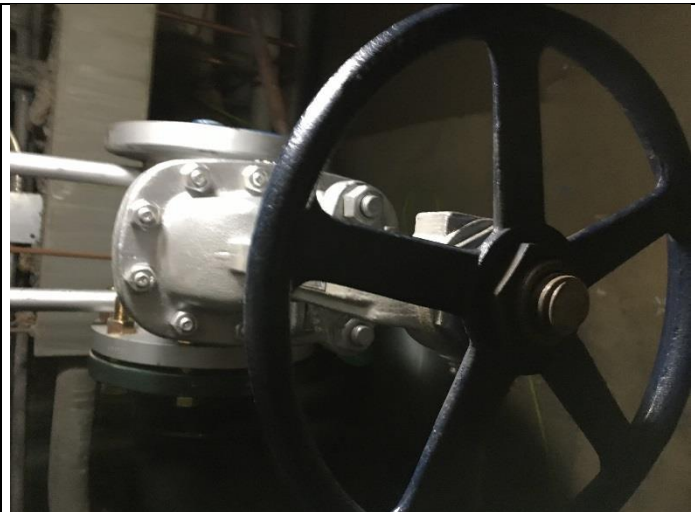
PHOTO 42 Silver Valve - Tunnel
<1mg/cm² lead

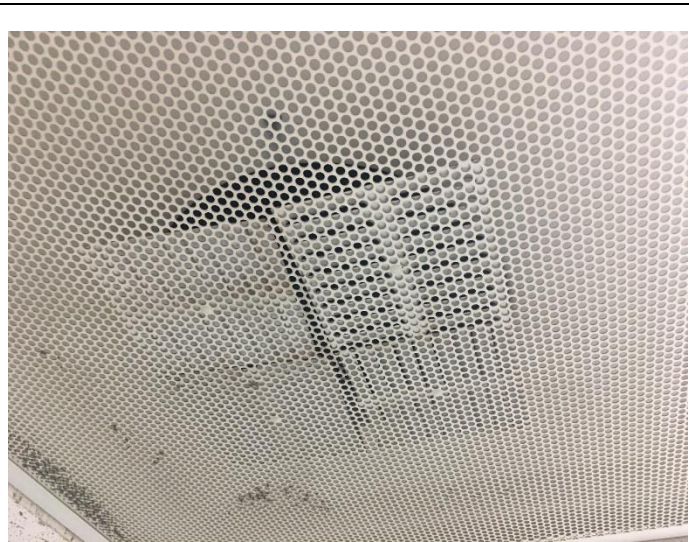
PHOTO 54 Diffuser Grate – Hallway by D-17
<1mg/cm² lead

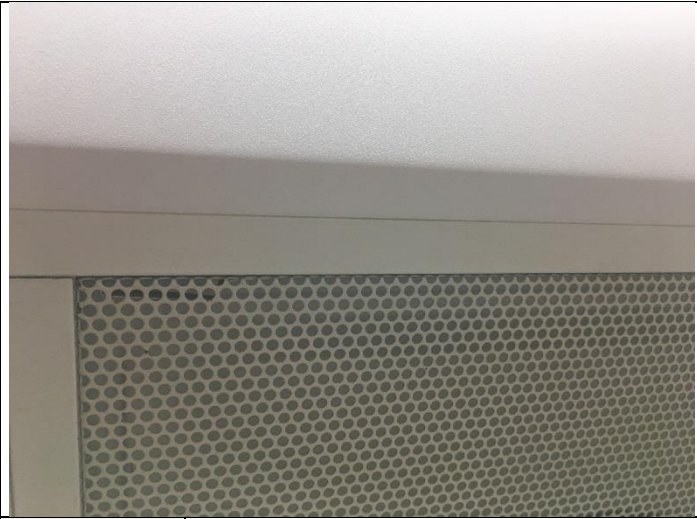
PHOTO 55 Ceiling Grid Hallway by D-17
<1mg/cm² lead

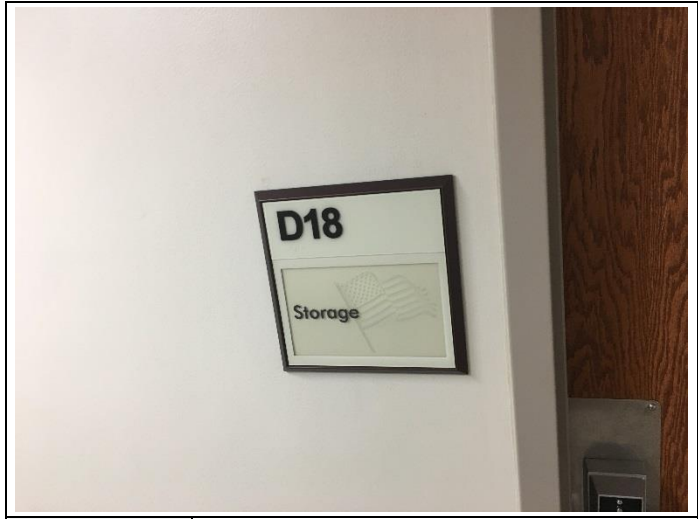
PHOTO 56 Beige Door Frame D-18
<1mg/cm² lead

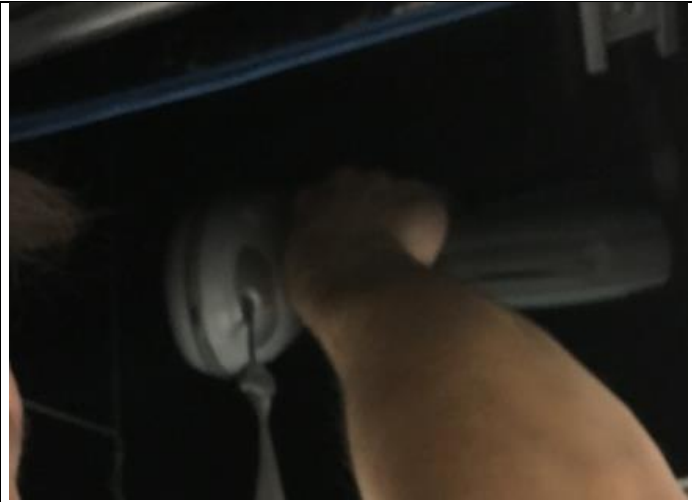
PHOTO 58 Black Pipe - Hallway
<1mg/cm² lead

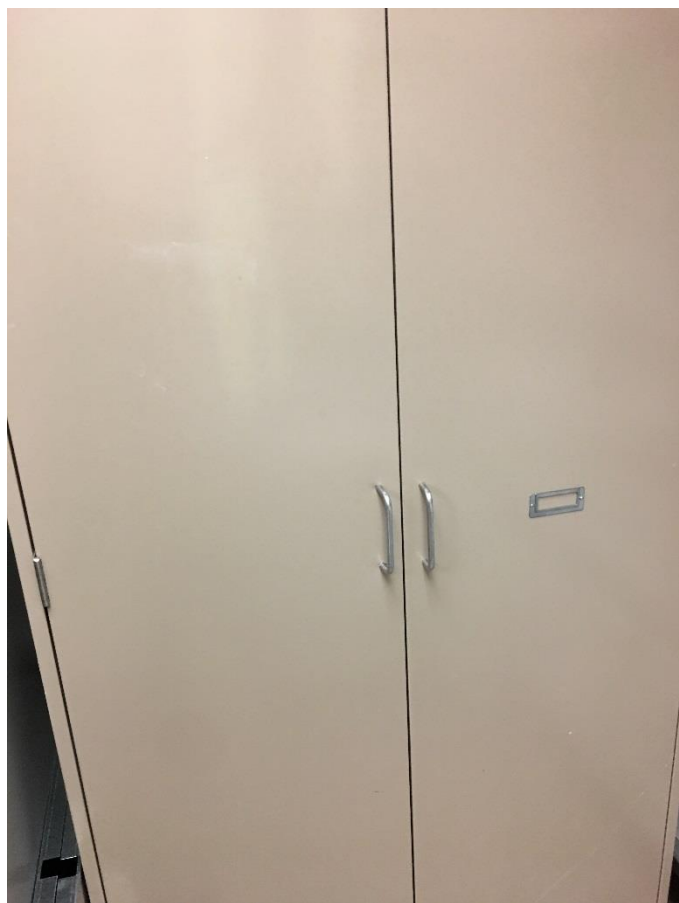
PHOTO 62 Beige Cabinet Room D-27
<1mg/cm² lead

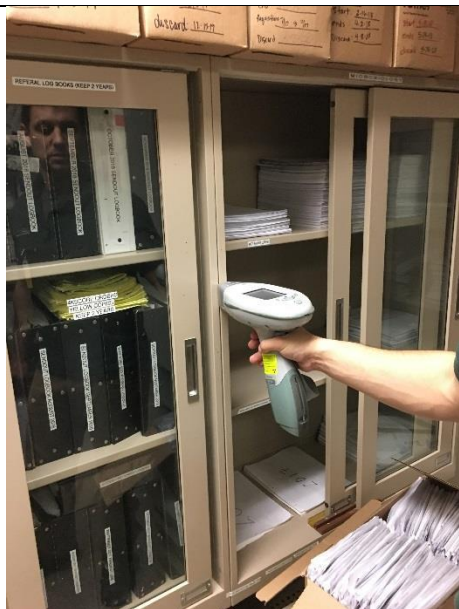
PHOTO 63 Beige Cabinet with Glass Room D-27
<1mg/cm² lead

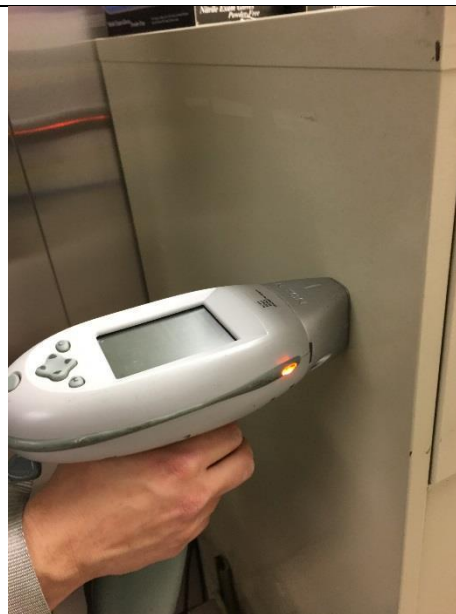
PHOTO 64 File Cabinet – S End
<1mg/cm² lead

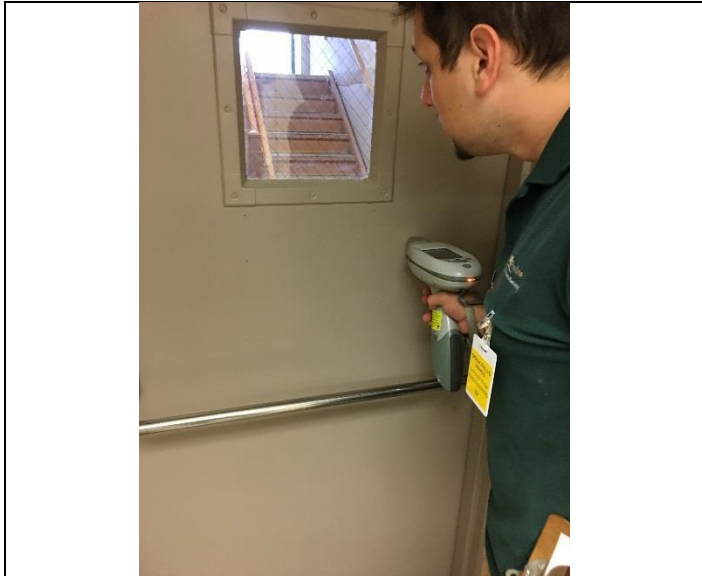
PHOTO 65 Cream Door – S End
<1mg/cm² lead

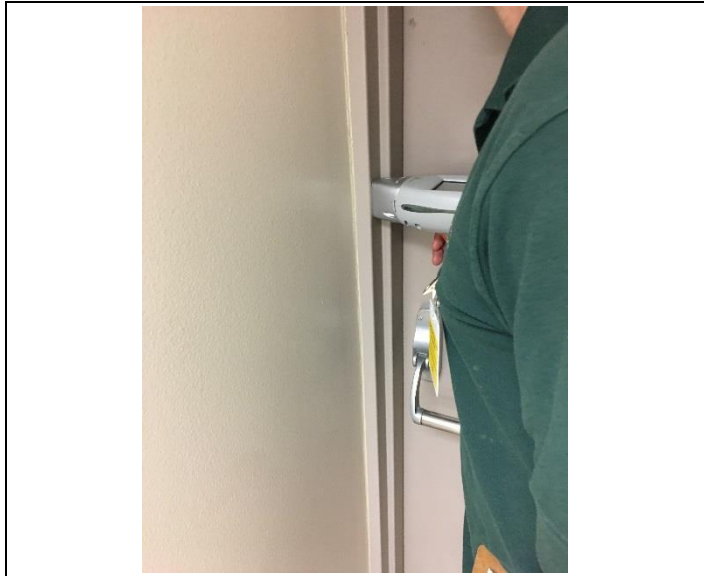
PHOTO 66 Cream Door Frame – S End
<1mg/cm² lead

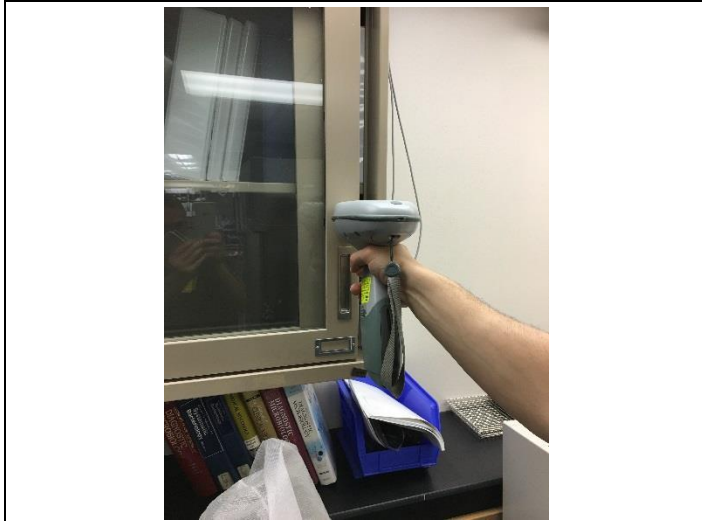
PHOTO 67 Beige Metal Cabinet – S End
<1mg/cm² lead

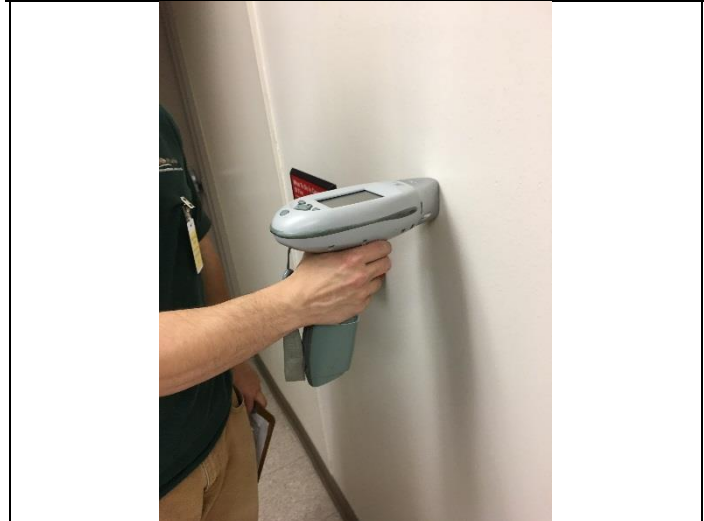
PHOTO 68 White Painted Sheetrock – West Wall
<1mg/cm² lead

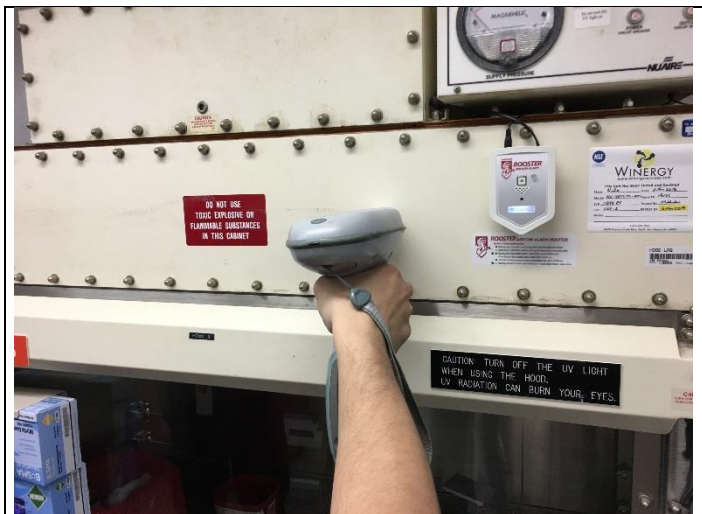
PHOTO 69 Cream Fume Hood – West Wall
<1mg/cm² lead

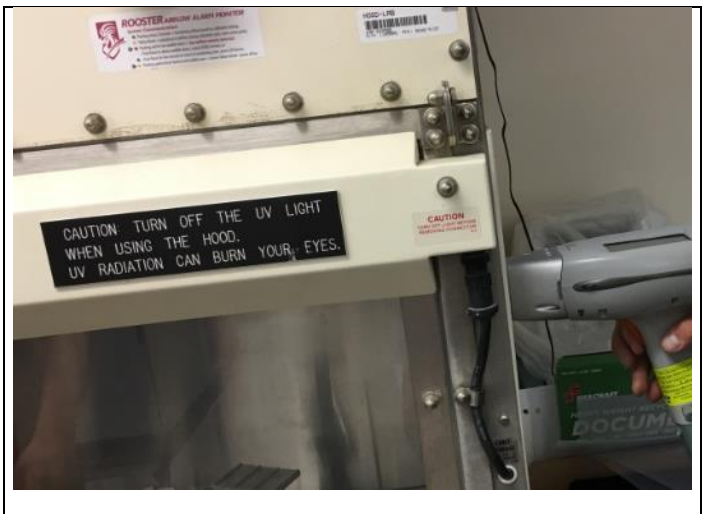
PHOTO 70 Cream Fume Hood – West Wall
<1mg/cm² lead

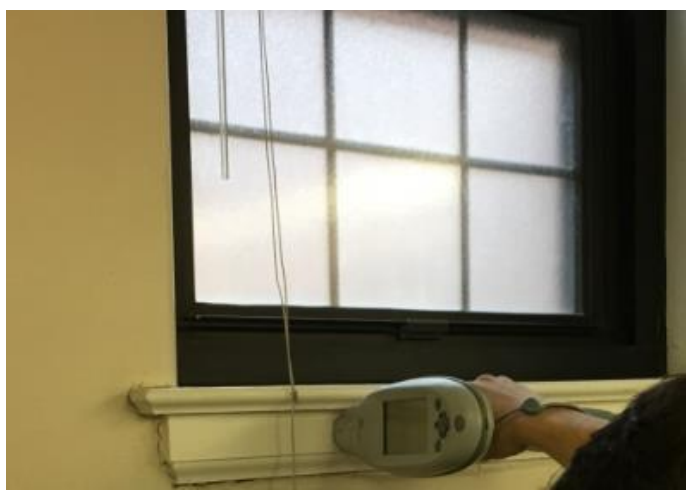
- LBP, brown, is present is present on exterior hand railings, near the entrance of the below grade mechanical room. (Approximately 150 linear ft.)
- LBP, brown, is present on decorative grates within the brick on exterior of the first floor of the building. (15 sq. ft.)
- LBP, white is present on top plate of 11 exterior windows (44 sq. ft.)
- LBP, brown, is present is present on interior hand railings on stairs leading to the tunnel. (Approximately 25 linear ft.)
- LBP, brown, is present on stairs leading to the tunnel. (100 sq. ft.)
- LBP, gray, is present on a ladder in the tunnel. (1 each)
- LBP, white, is present on window sills in the interior windows of the Inspection Area. (50 sq. ft.)

PHOTO 71 Window Sill and Trim Below Window
5.3 mg/cm² lead

Based on the initial lead paint testing results, AMIE recommends TCLP testing be conducted on the existing building materials, painted and unpainted, prior to the start of renovation or demolition activity. In addition, trade contractors who work in the facility should also be notified of the presence of lead so that they can appropriately monitor and protect their workers against lead exposure.

Any lead-based painted building components not removed during renovation should be considered for inclusion in a facility management plan that maintains potential exposure below OSHA action levels and ensures the material will be handled properly and in accordance with applicable regulations.

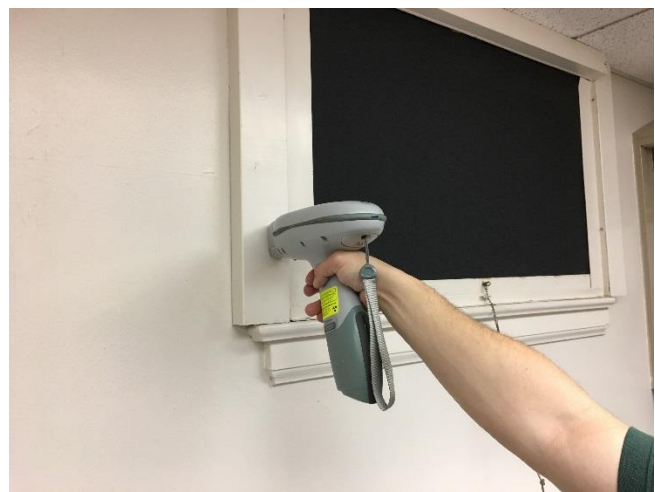
PHOTO 72 Non-Decorative Window Trim
<1mg/cm² lead

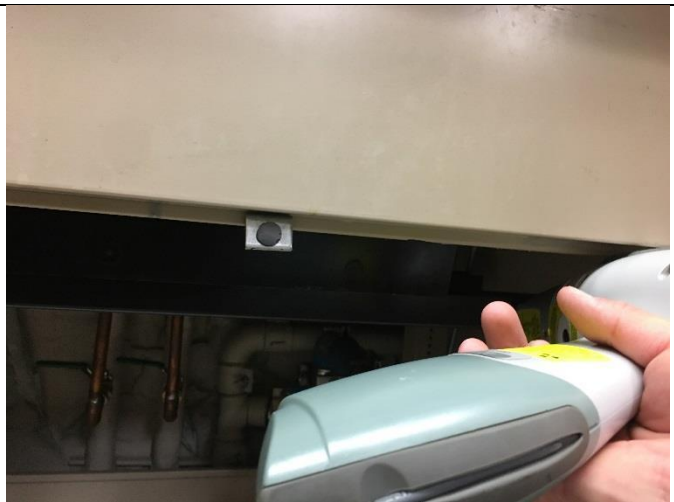
PHOTO 74 Black Metal surrounding sink basin
<1mg/cm² lead

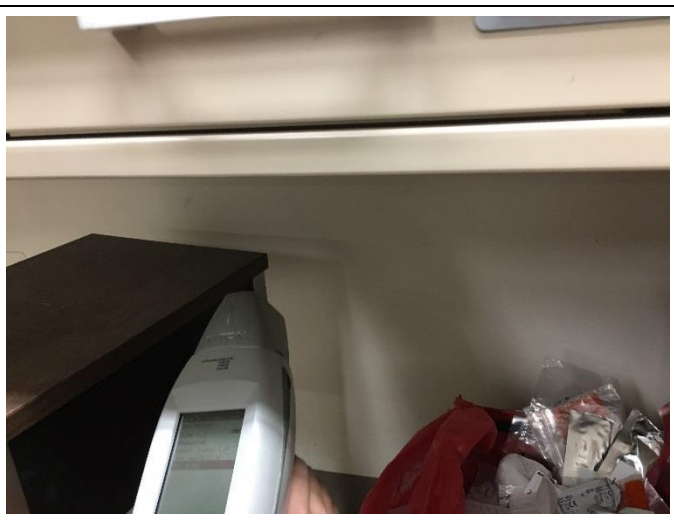
PHOTO 76 White Paint on Plaster
<1mg/cm² lead
