HAZARDOUS BUILDING MATERIALS INSPECTION REPORT

Sioux Falls VA Medical Center

**New SPS Addition
Sioux Falls, South Dakota**

VA Project No: 438-460

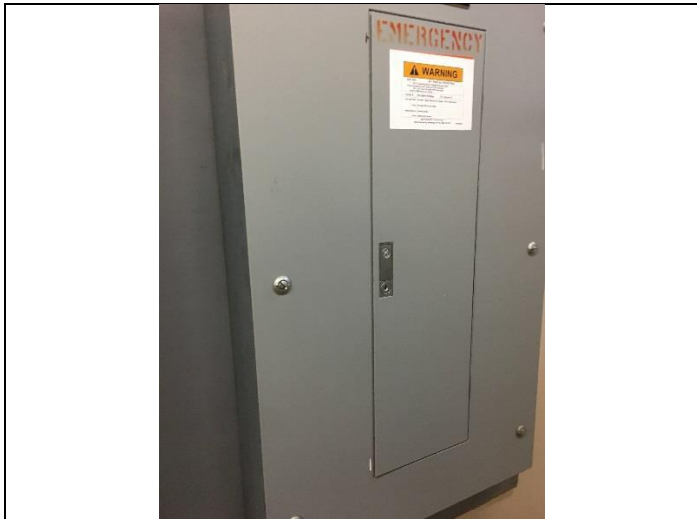
PHOTO 83 Breaker Box – D-20
<1mg/cm² lead

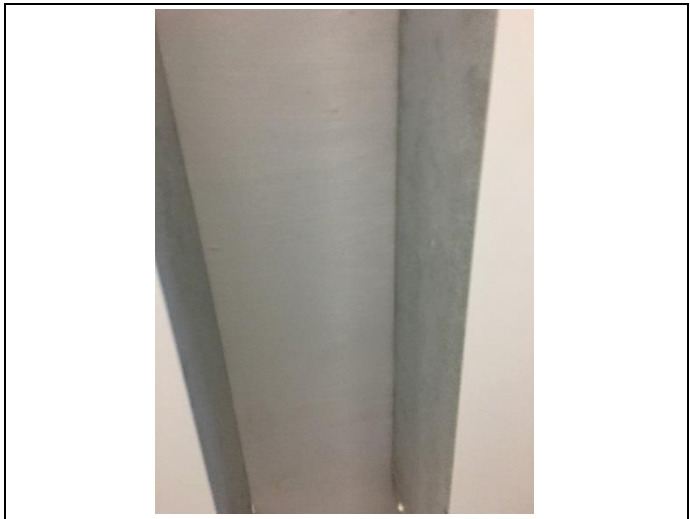
PHOTO 84 Panel behind Breaker Box – D-20
<1mg/cm² lead

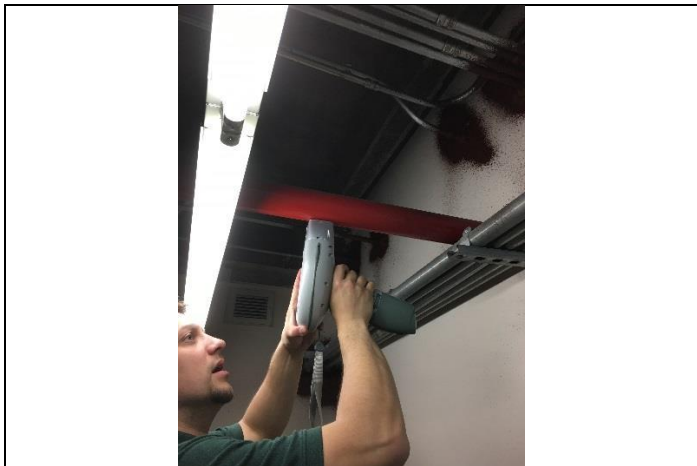
PHOTO 85 Red Metal Pipe – D-20
<1mg/cm² lead

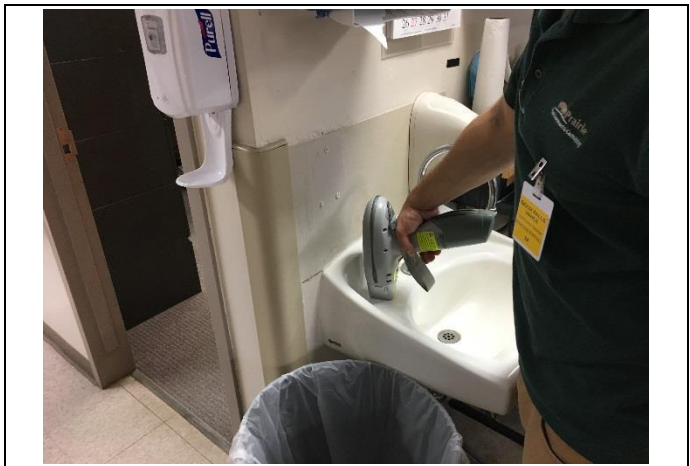
PHOTO 86 Porcelain Sink – Lab
<1mg/cm² lead

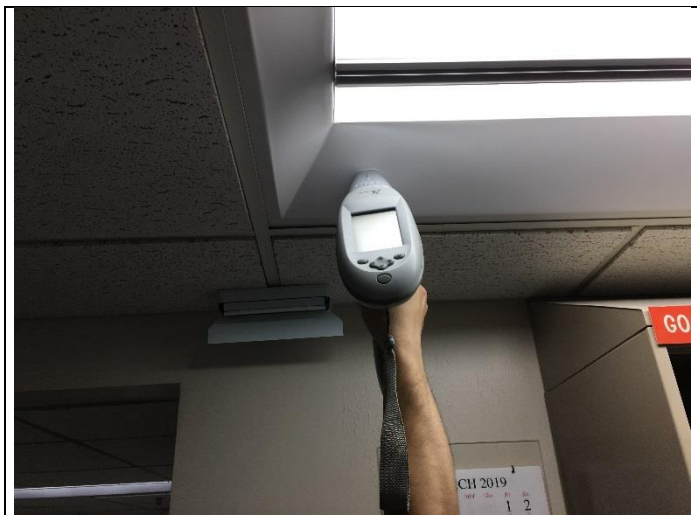
PHOTO 87 Ceiling Light Fixture
<1mg/cm² lead

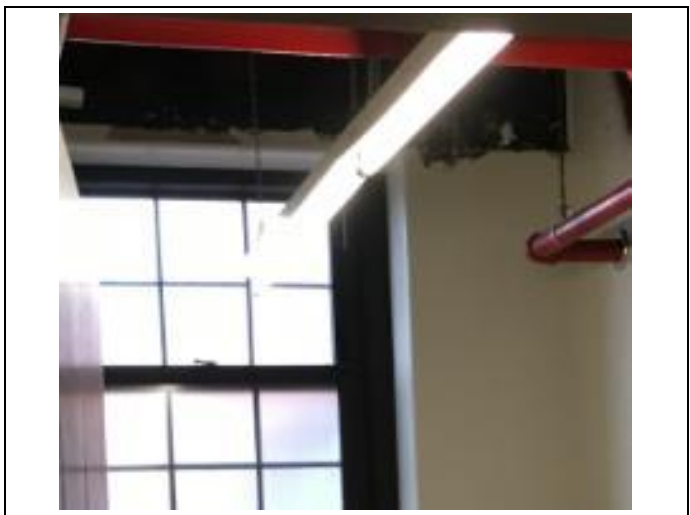
PHOTO 88 Black Concrete Wall Above Window – D-20
<1mg/cm² lead
