Solicitation Questions and Answers

Asbestos
Sample Locations
&
Laboratory Report

Brooklyn Park, MN 55445 **Project:** 202010234- SCVAMC B50

XRF Lead-Based Report

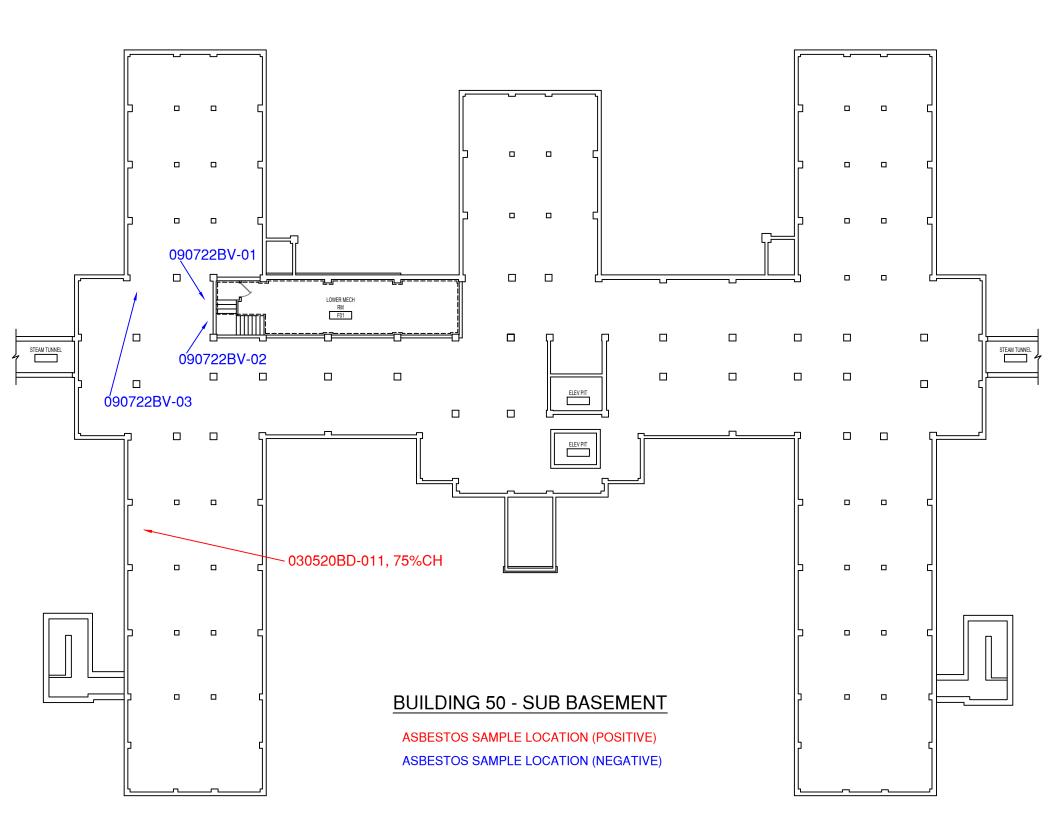
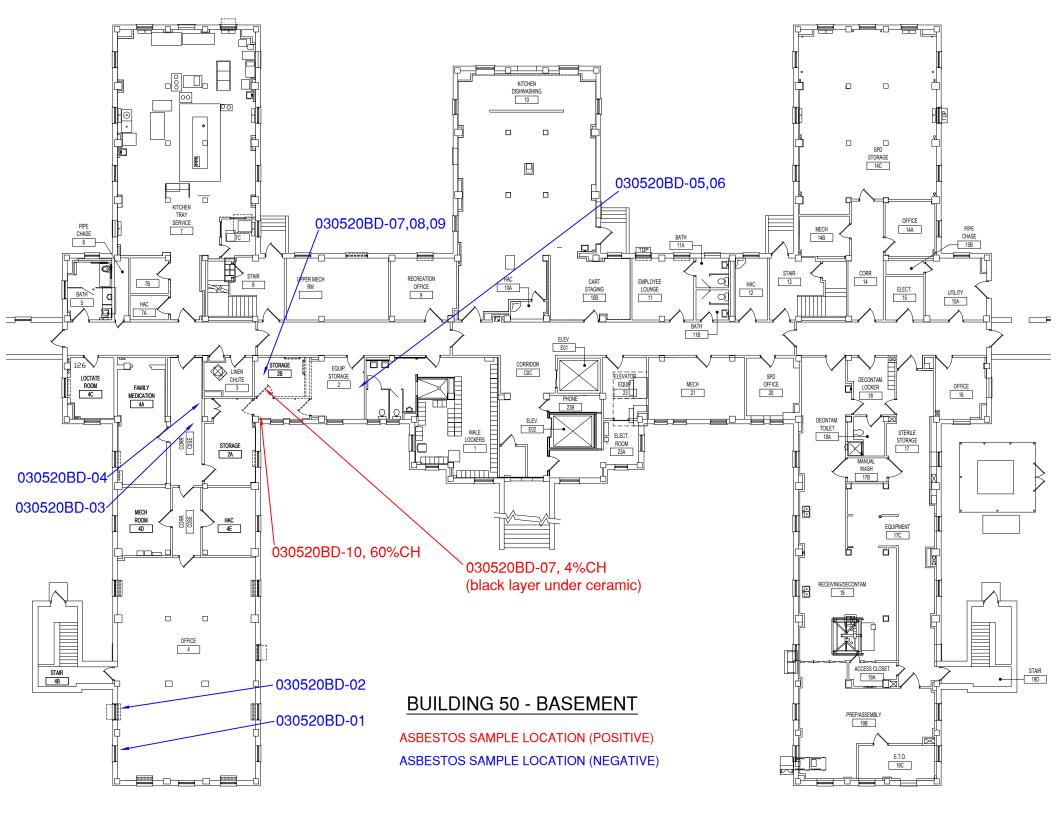
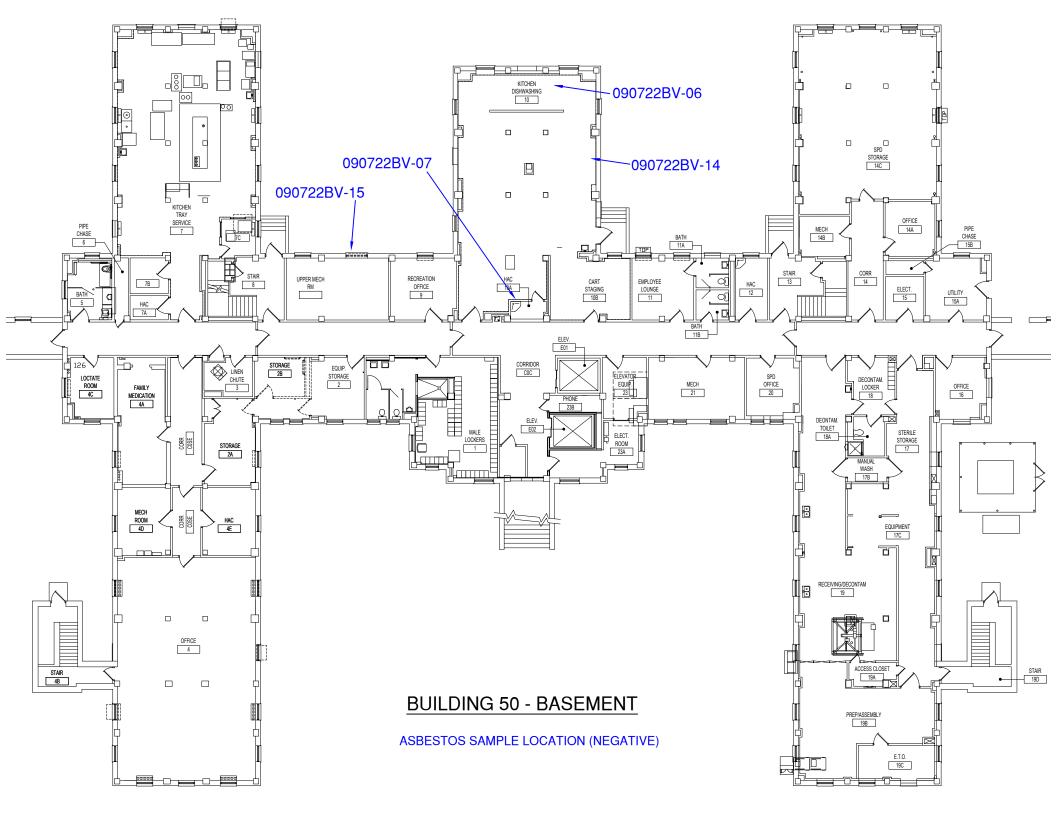
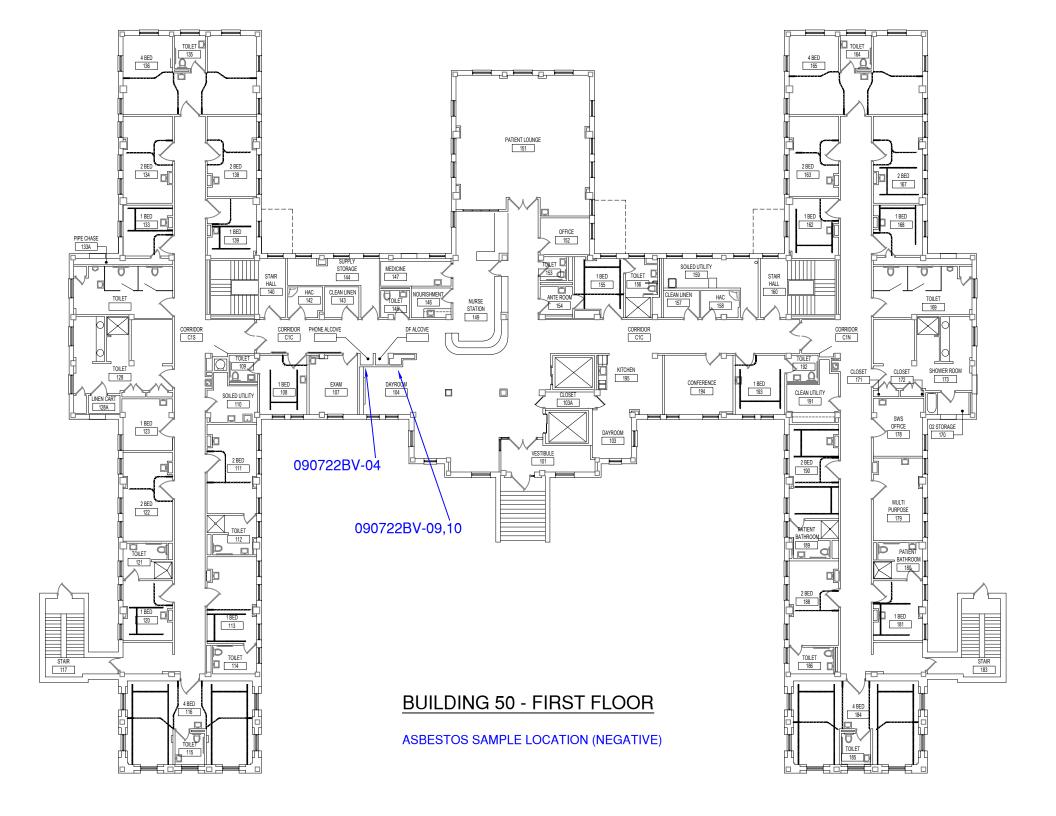
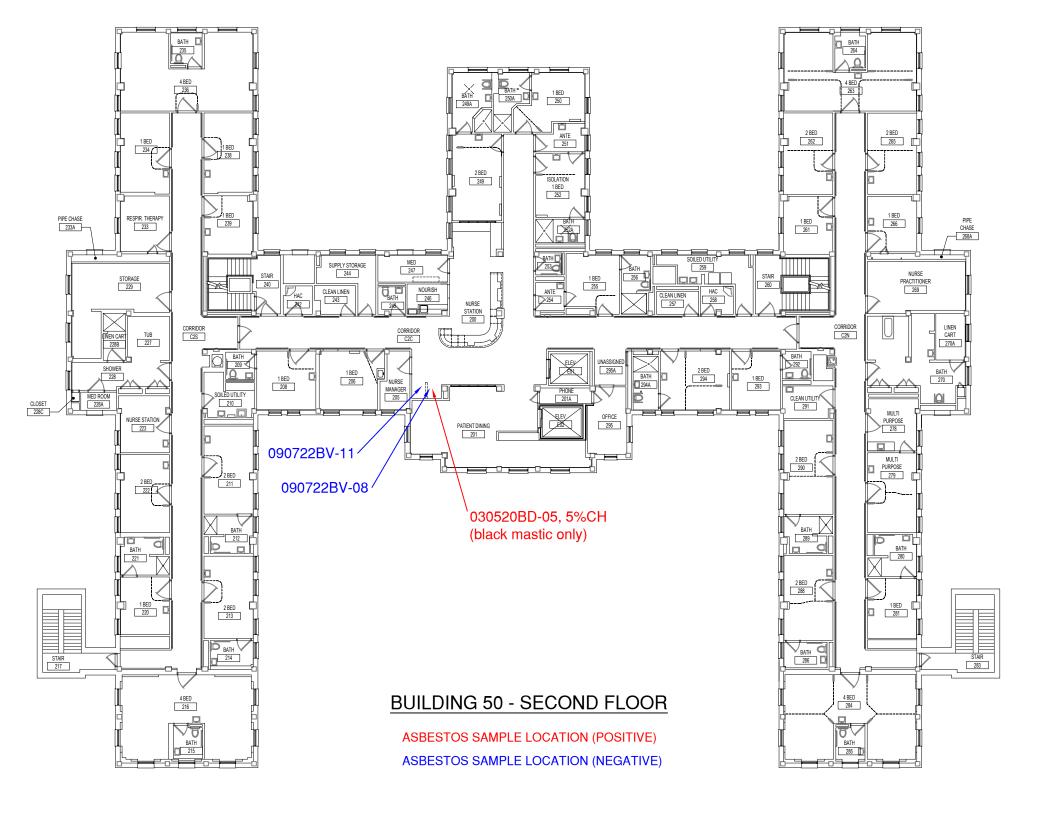
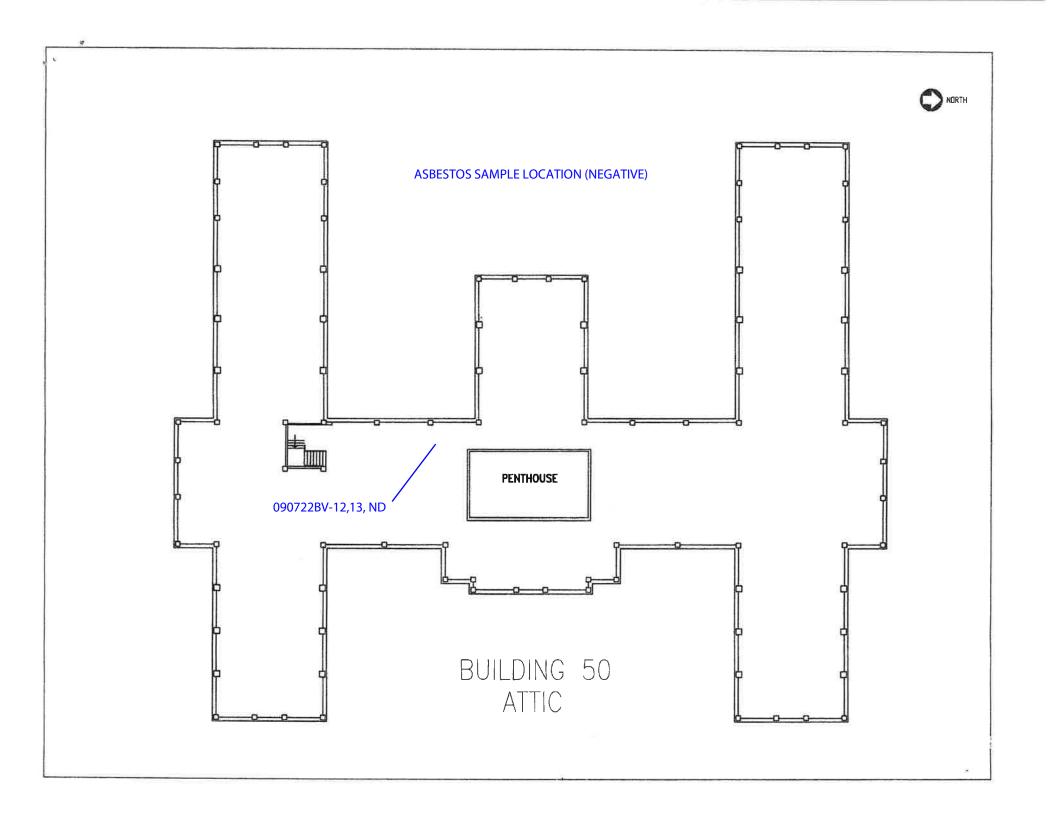
Non-A	<u>Asbestos</u>	<u>Asbestos</u>
Sample	Description	Appearance	% Fibrous	% Non-Fibrous	% Type
030520BD-07	Rm 2B, 1x1 Ceramic	Black		96.0% Non-fibrous (Other)	4% Chrysotile
Mastic	Floor Tile System	Non-Fibrous			
352002390-0007C	(Brown), X1A	Homogeneous			
030520BD-08	Rm 2B, 4x4 Ceramic	White		100.0% Non-fibrous (Other)	None Detected
Ceramic Tile	Wall Tile System	Non-Fibrous			
352002390-0008	(Beige), X1B	Homogeneous			
030520BD-08 Grout	Rm 2B, 4x4 Ceramic	White		100.0% Non-fibrous (Other)	None Detected
352002390-0008A	Wall Tile System	Non-Fibrous			
	(Beige), X1B	Homogeneous			
030520BD-08	Rm 2B, 4x4 Ceramic	Tan		100.0% Non-fibrous (Other)	None Detected
Mastic	Wall Tile System	Non-Fibrous			
352002390-0008B	(Beige), X1B	Homogeneous			
030520BD-08 Caulk	Rm 2B, 4x4 Ceramic	White		100.0% Non-fibrous (Other)	None Detected
352002390-0008C	Wall Tile System	Non-Fibrous			
	(Beige), X1B	Homogeneous			
030520BD-09	Rm 2B, 4x4 Ceramic	White		100.0% Non-fibrous (Other)	None Detected

Non-A	<u>asbestos</u>	<u>Asbestos</u>
Sample	Description	Appearance	% Fibrous	% Non-Fibrous	% Type
030520BD-11	Crawl Space, Aircell	Gray		25.0% Non-fibrous (Other)	75% Chrysotile
352002390-0011	Debris in Dirt, B1A	Fibrous			
		Homogeneous

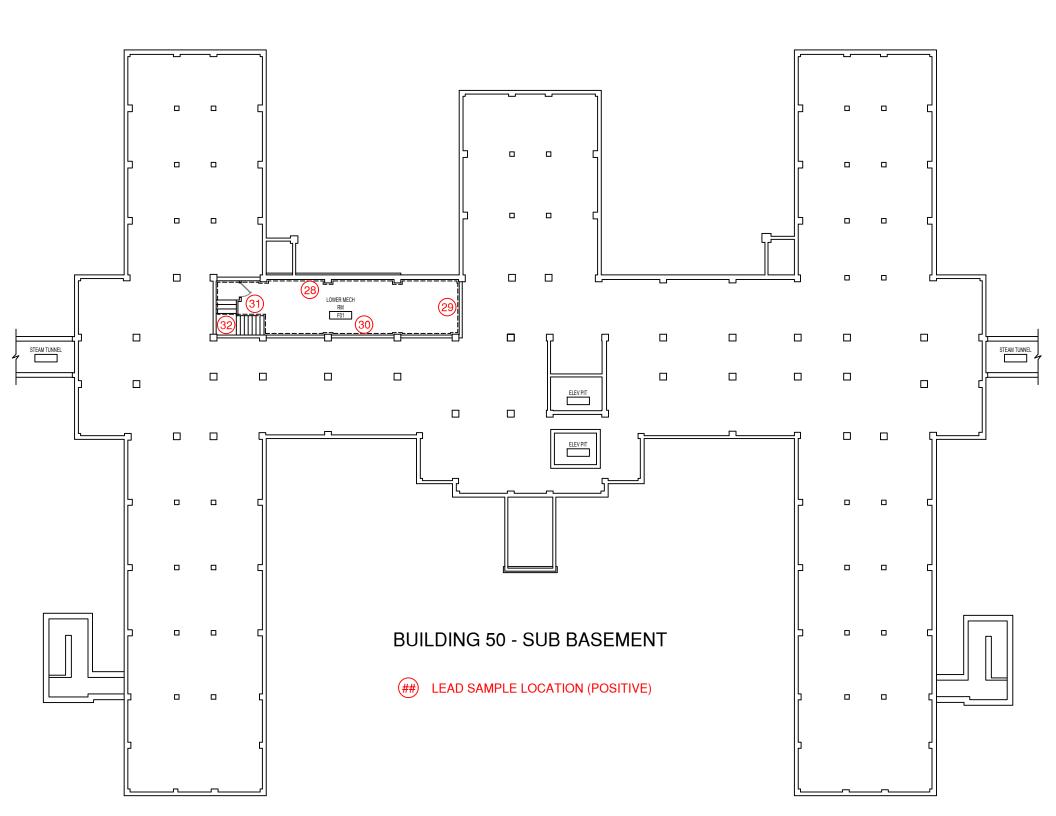
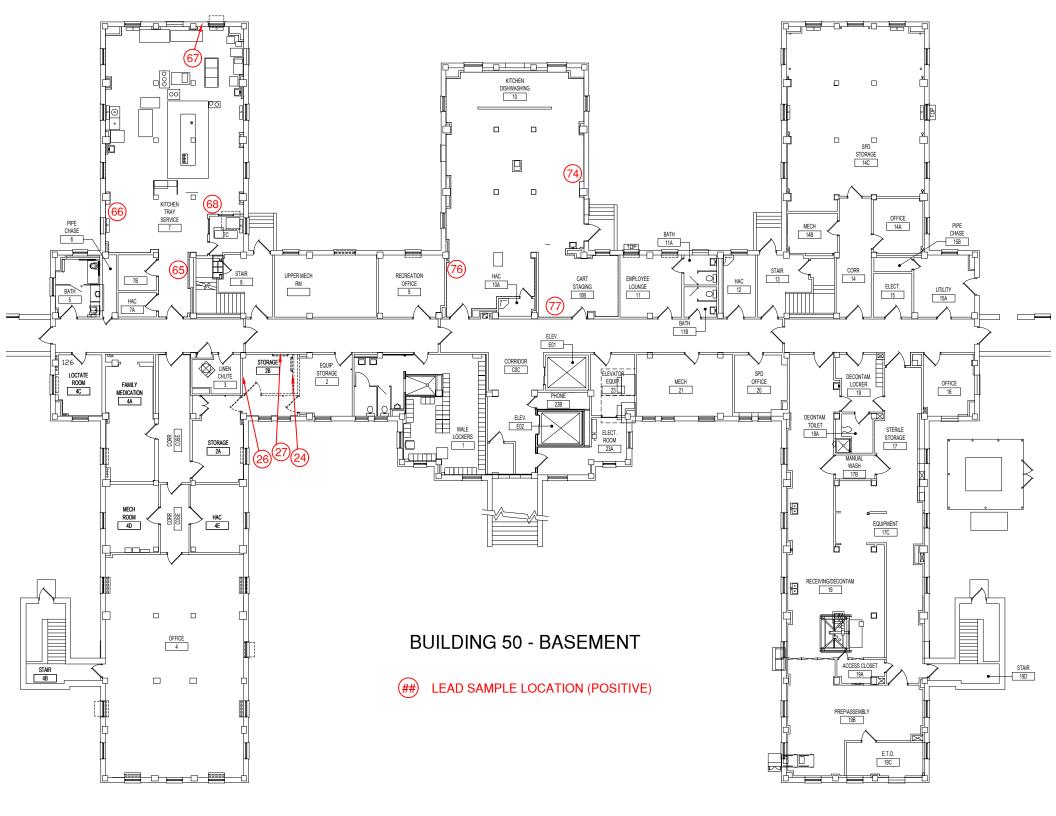
14	3/5/2020 10:46	1.34	Door	Metal	Brown	Intact	South	4	Negative	1	0
15	3/5/2020 10:46	1.34	Pipe	Metal	White	Intact	554	4	Negative	2.05	0.04
16	3/5/2020 11:11	3.58	Wall	Plaster	Gray	Intact	South	2	Negative	1	0
17	3/5/2020 11:11	3.55	Wall	Plaster	Beige	Intact	West	2	Negative	1	0
18	3/5/2020 11:12	3.57	Wall	Plaster	Beige	Intact	North	2	Negative	1	0
19	3/5/2020 11:12 3/5/2020 11:13	6.24	Baseboard	Vinyl	Brown	Intact	North	2	Negative	1	0
20 21	3/5/2020 11:13	1.34 1.34	Door Door Frame	Metal Metal	Brown Brown	Intact Intact	West West	2 2	Negative Negative	1 1	0 0
22	3/5/2020 11:13	3.58	Ceiling	Concrete	White	Peeling	WCSt	2	Negative	2.56	0.05
23	3/5/2020 11:16	1.35	Floor	Ceramic	Brown	Intact		2-B	Negative	1	0
24	3/5/2020 11:16	3.57	Wall	Ceramic	Beige	Intact	North	2-B	Positive	2.24	1.5
25	3/5/2020 11:17	3.6	Wall	Ceramic	White	Intact	East	2-B	Negative	2.33	0.02
26	3/5/2020 11:18	4.49	Wall	Ceramic	Beige	Intact	South	2-B	Positive	2.01	1.3

27 28	3/5/2020 11:19 3/5/2020 11:56	1.78 1.34	Wall Wall	Ceramic	Beige	Intact	West West	2-B	Positive Positive	2.89 1.67	2 2
28 29	3/5/2020 11:56	1.78	Wall	Concrete Concrete	Beige Beige	Intact Intact	North	B50 Service Room B50 Service Room	Positive	1.55	1.7
30	3/5/2020 11:57	13.46	Wall	Concrete	Beige	Intact	East	B50 Service Room	Positive	1.41	1.1
31	3/5/2020 12:00	2.24	Wall	Block	Beige	Intact	South	B50 Service Room Stairs	Positive	1.58	1.6
32	3/5/2020 12:01	3.13	Ceiling	Plaster	Beige	Intact	South	B50 Service Room Stairs	Positive	1.63	1.4
33	3/5/2020 12:03	4.92	Wall	Plaster	Beige	Intact	West	Hall by RR 5	Negative	7.9	0.14
34	3/5/2020 12:06	3.59	Ceiling	Plaster	Beige	Intact	Nauth	Hall by RR 5	Negative	3.28	0.06
35 36	3/5/2020 12:08 3/5/2020 12:09	2.23 1.34	Wall Ceiling	Drywall Concrete	Beige White	Intact Intact	North	RM 4 Corridor RM 4 Corridor	Negative Negative	1 1	0 0.01
37	3/5/2020 12:03	4.47	Wall	Plaster	Beige	Intact	East	Hall by RM 1-C	Negative	5.39	0.16
