Asbestos Re-Inspection Report

Sioux Falls Federal Building/Courthouse
Sioux Falls, South Dakota
GSA Building No. SD0021

1/13-346-09.8005.0016

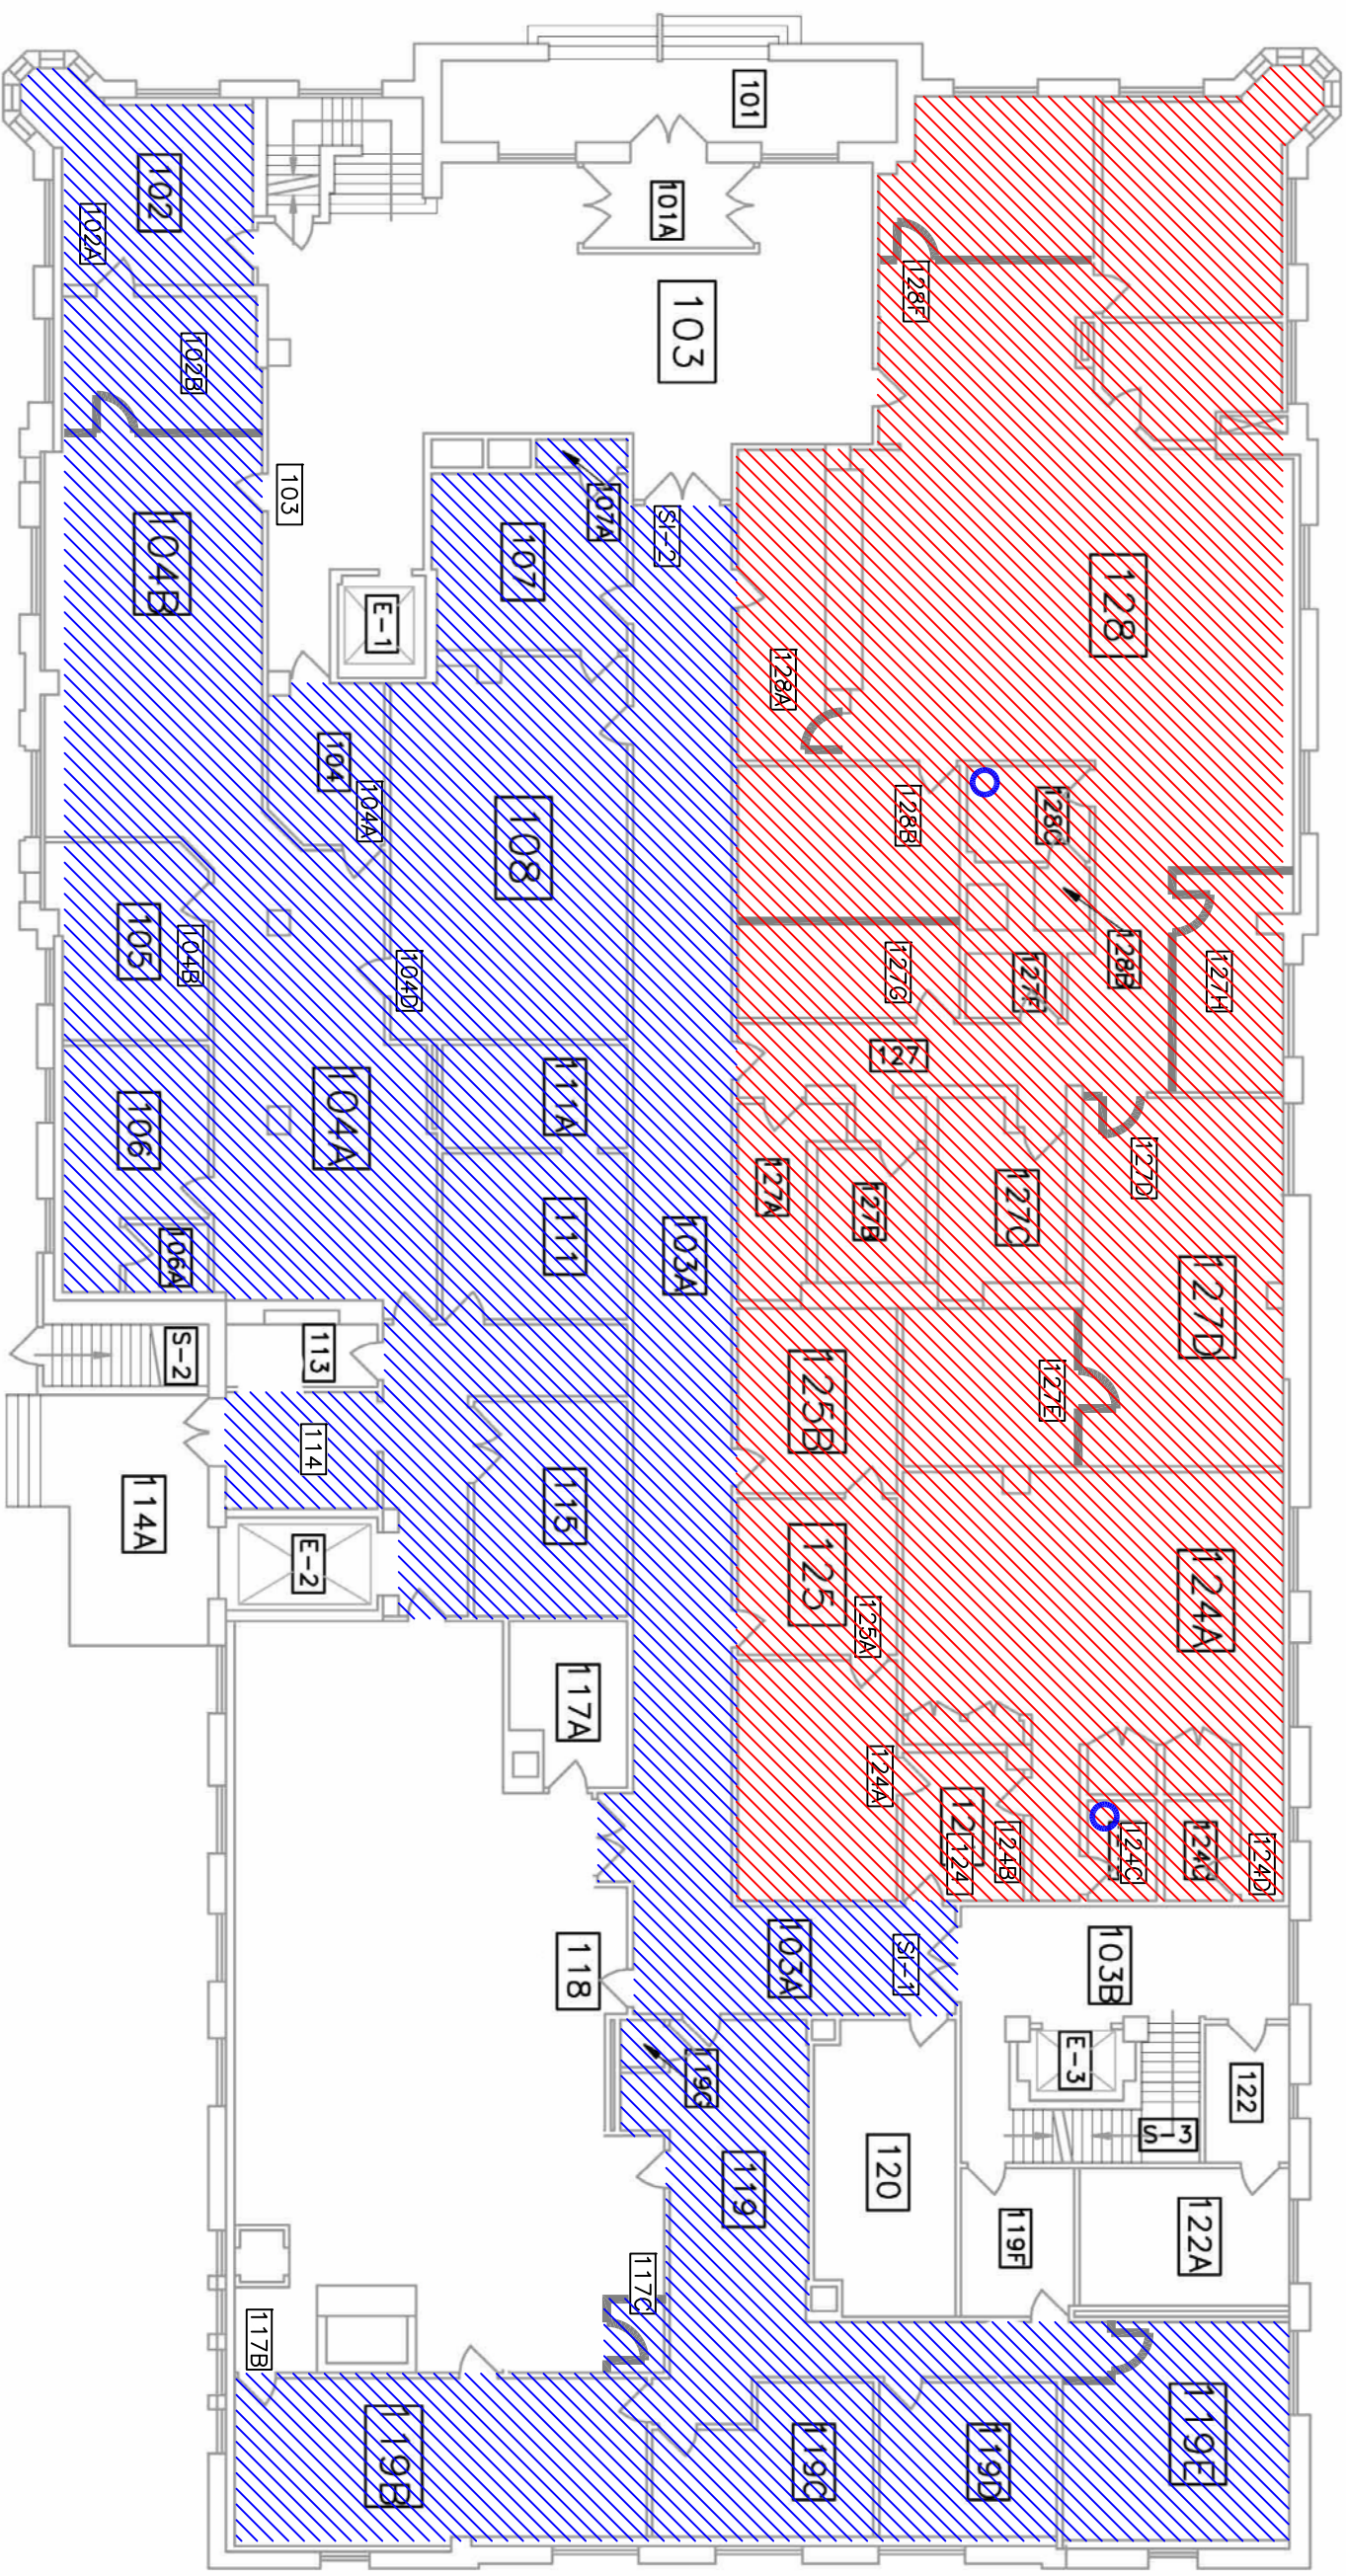
Figure A-5
Date: February 21, 2014

- LEGEND**
- Room Number
 - ACM 12"x12" Floor Tile and Mastic: *(F2.4)
 - ACM Black Mastic Under Carpet, Vinyl Sheet Flooring or Tile: *(F5.1)
 - ACM Sink Undercoating (M10.1)

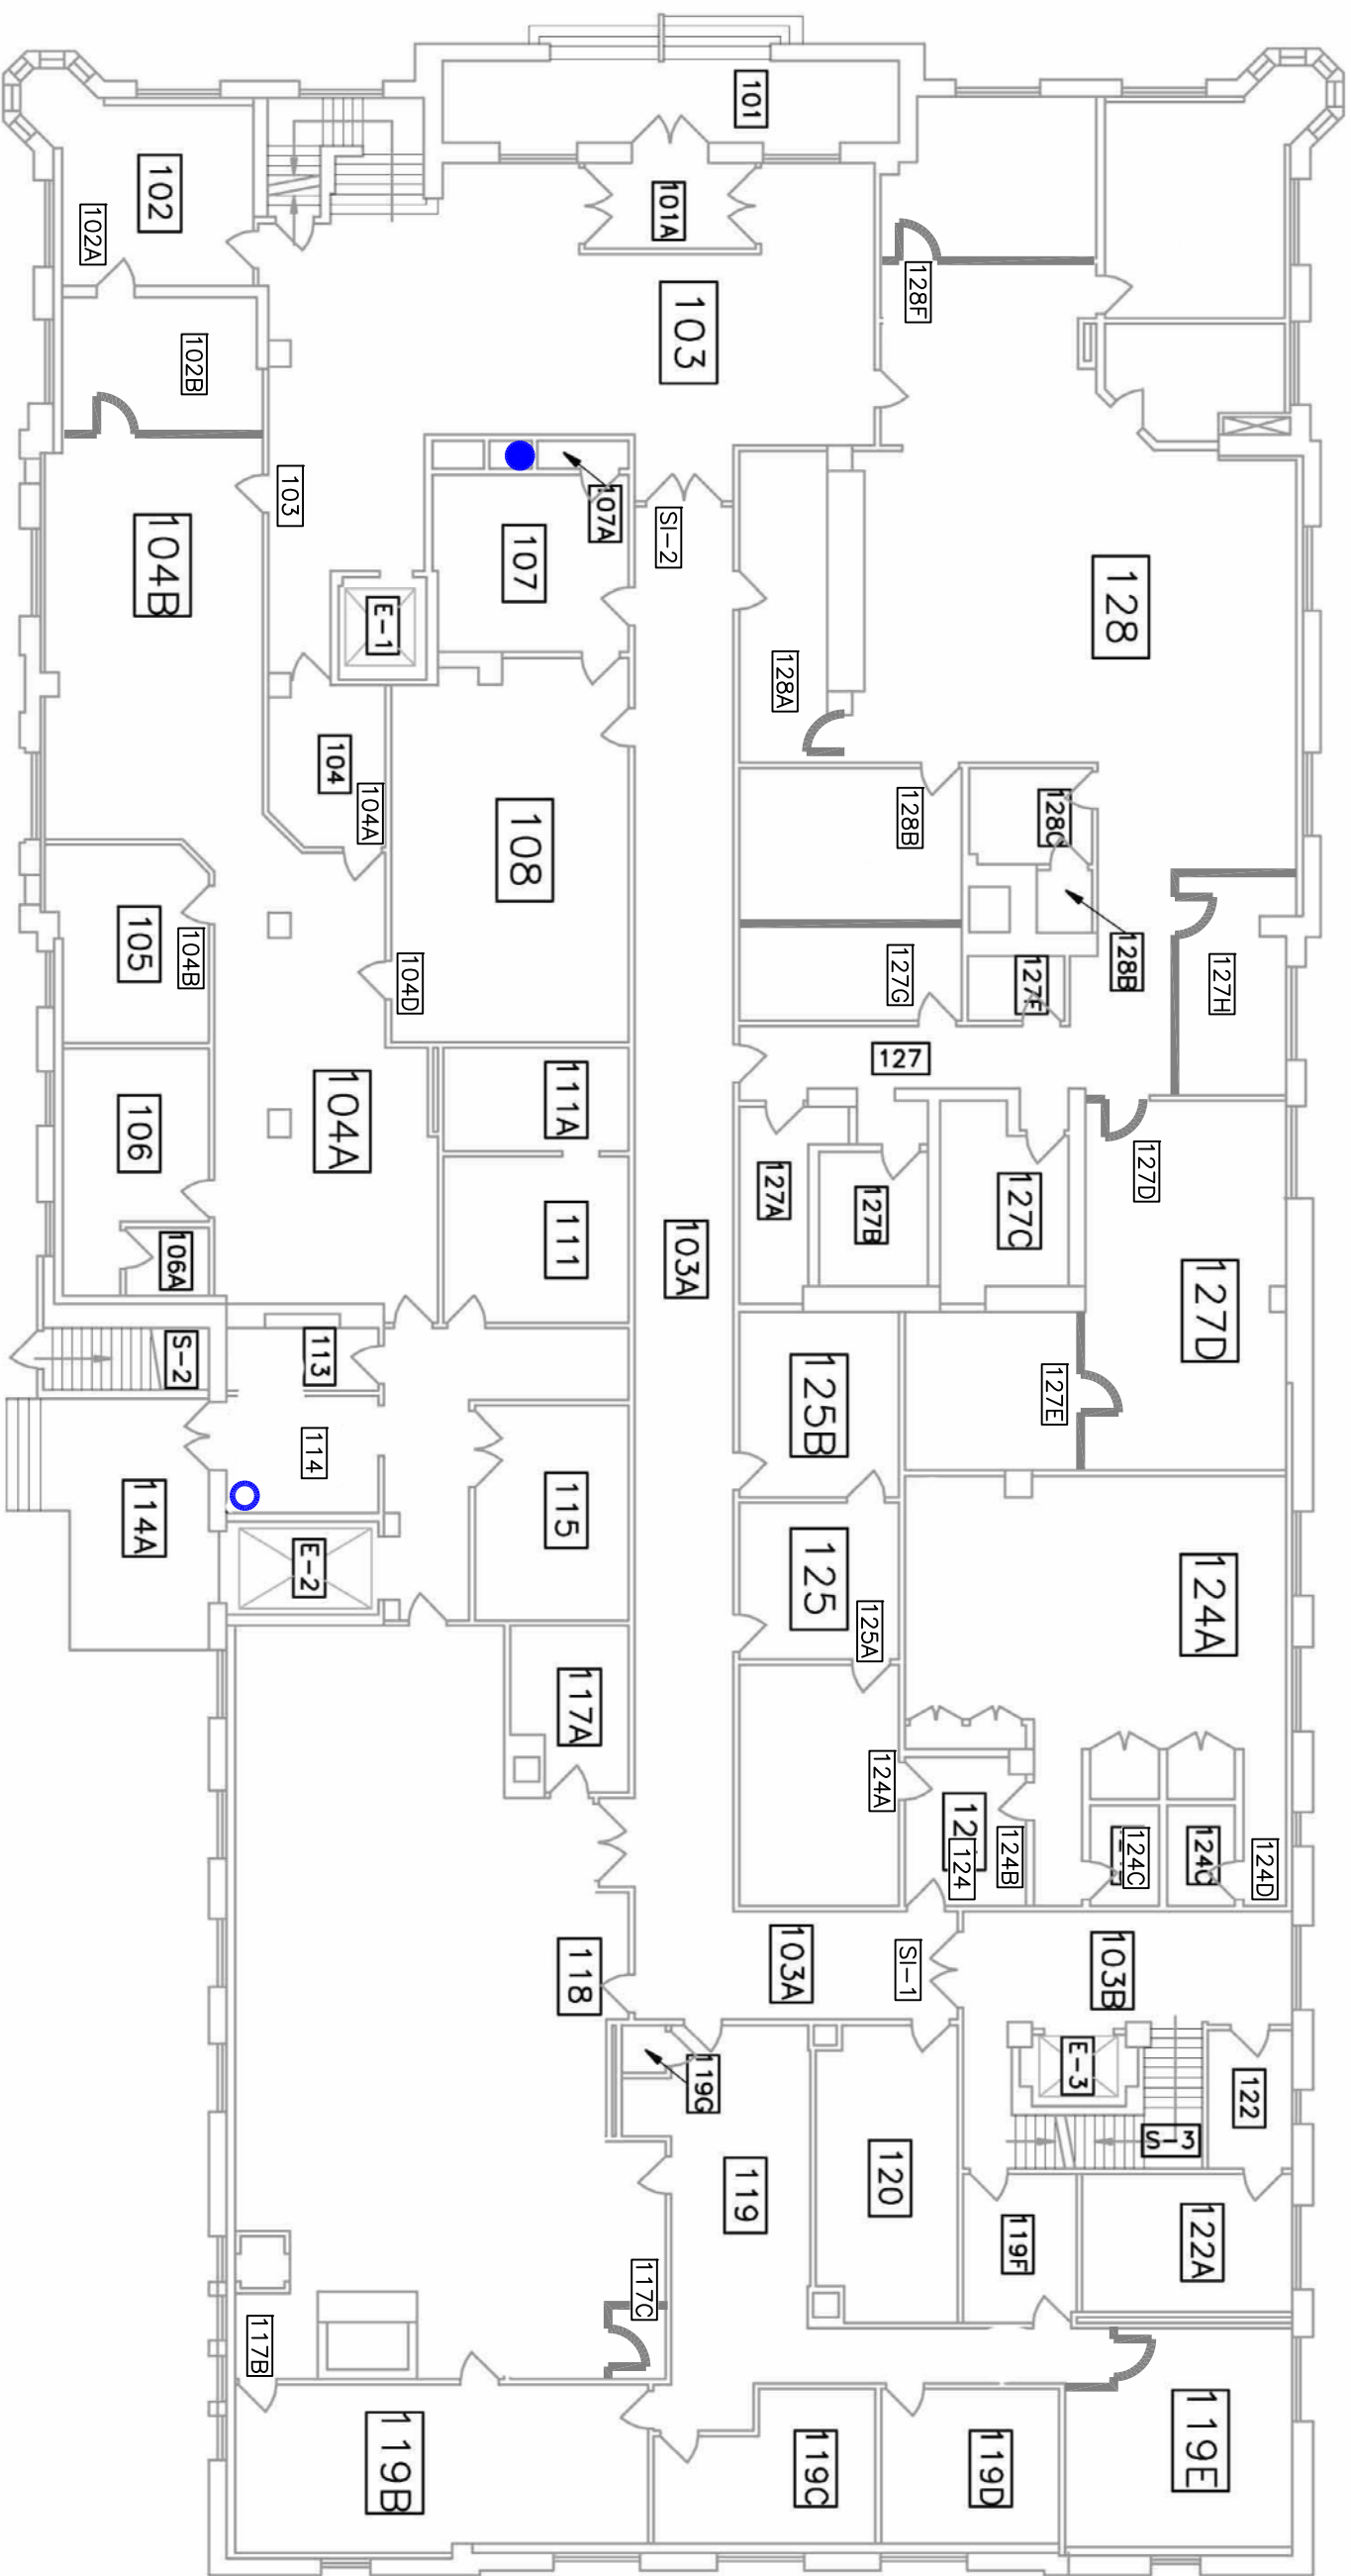
Figure A-6
Date: February 21, 2014

- LEGEND**
- 103 Room Number
 - ACM Mudded Fittings on Vent Lines. *(T2.7)
 - ACM Hard Straight Run on Abandoned Heating Pipes. *(T3.7)

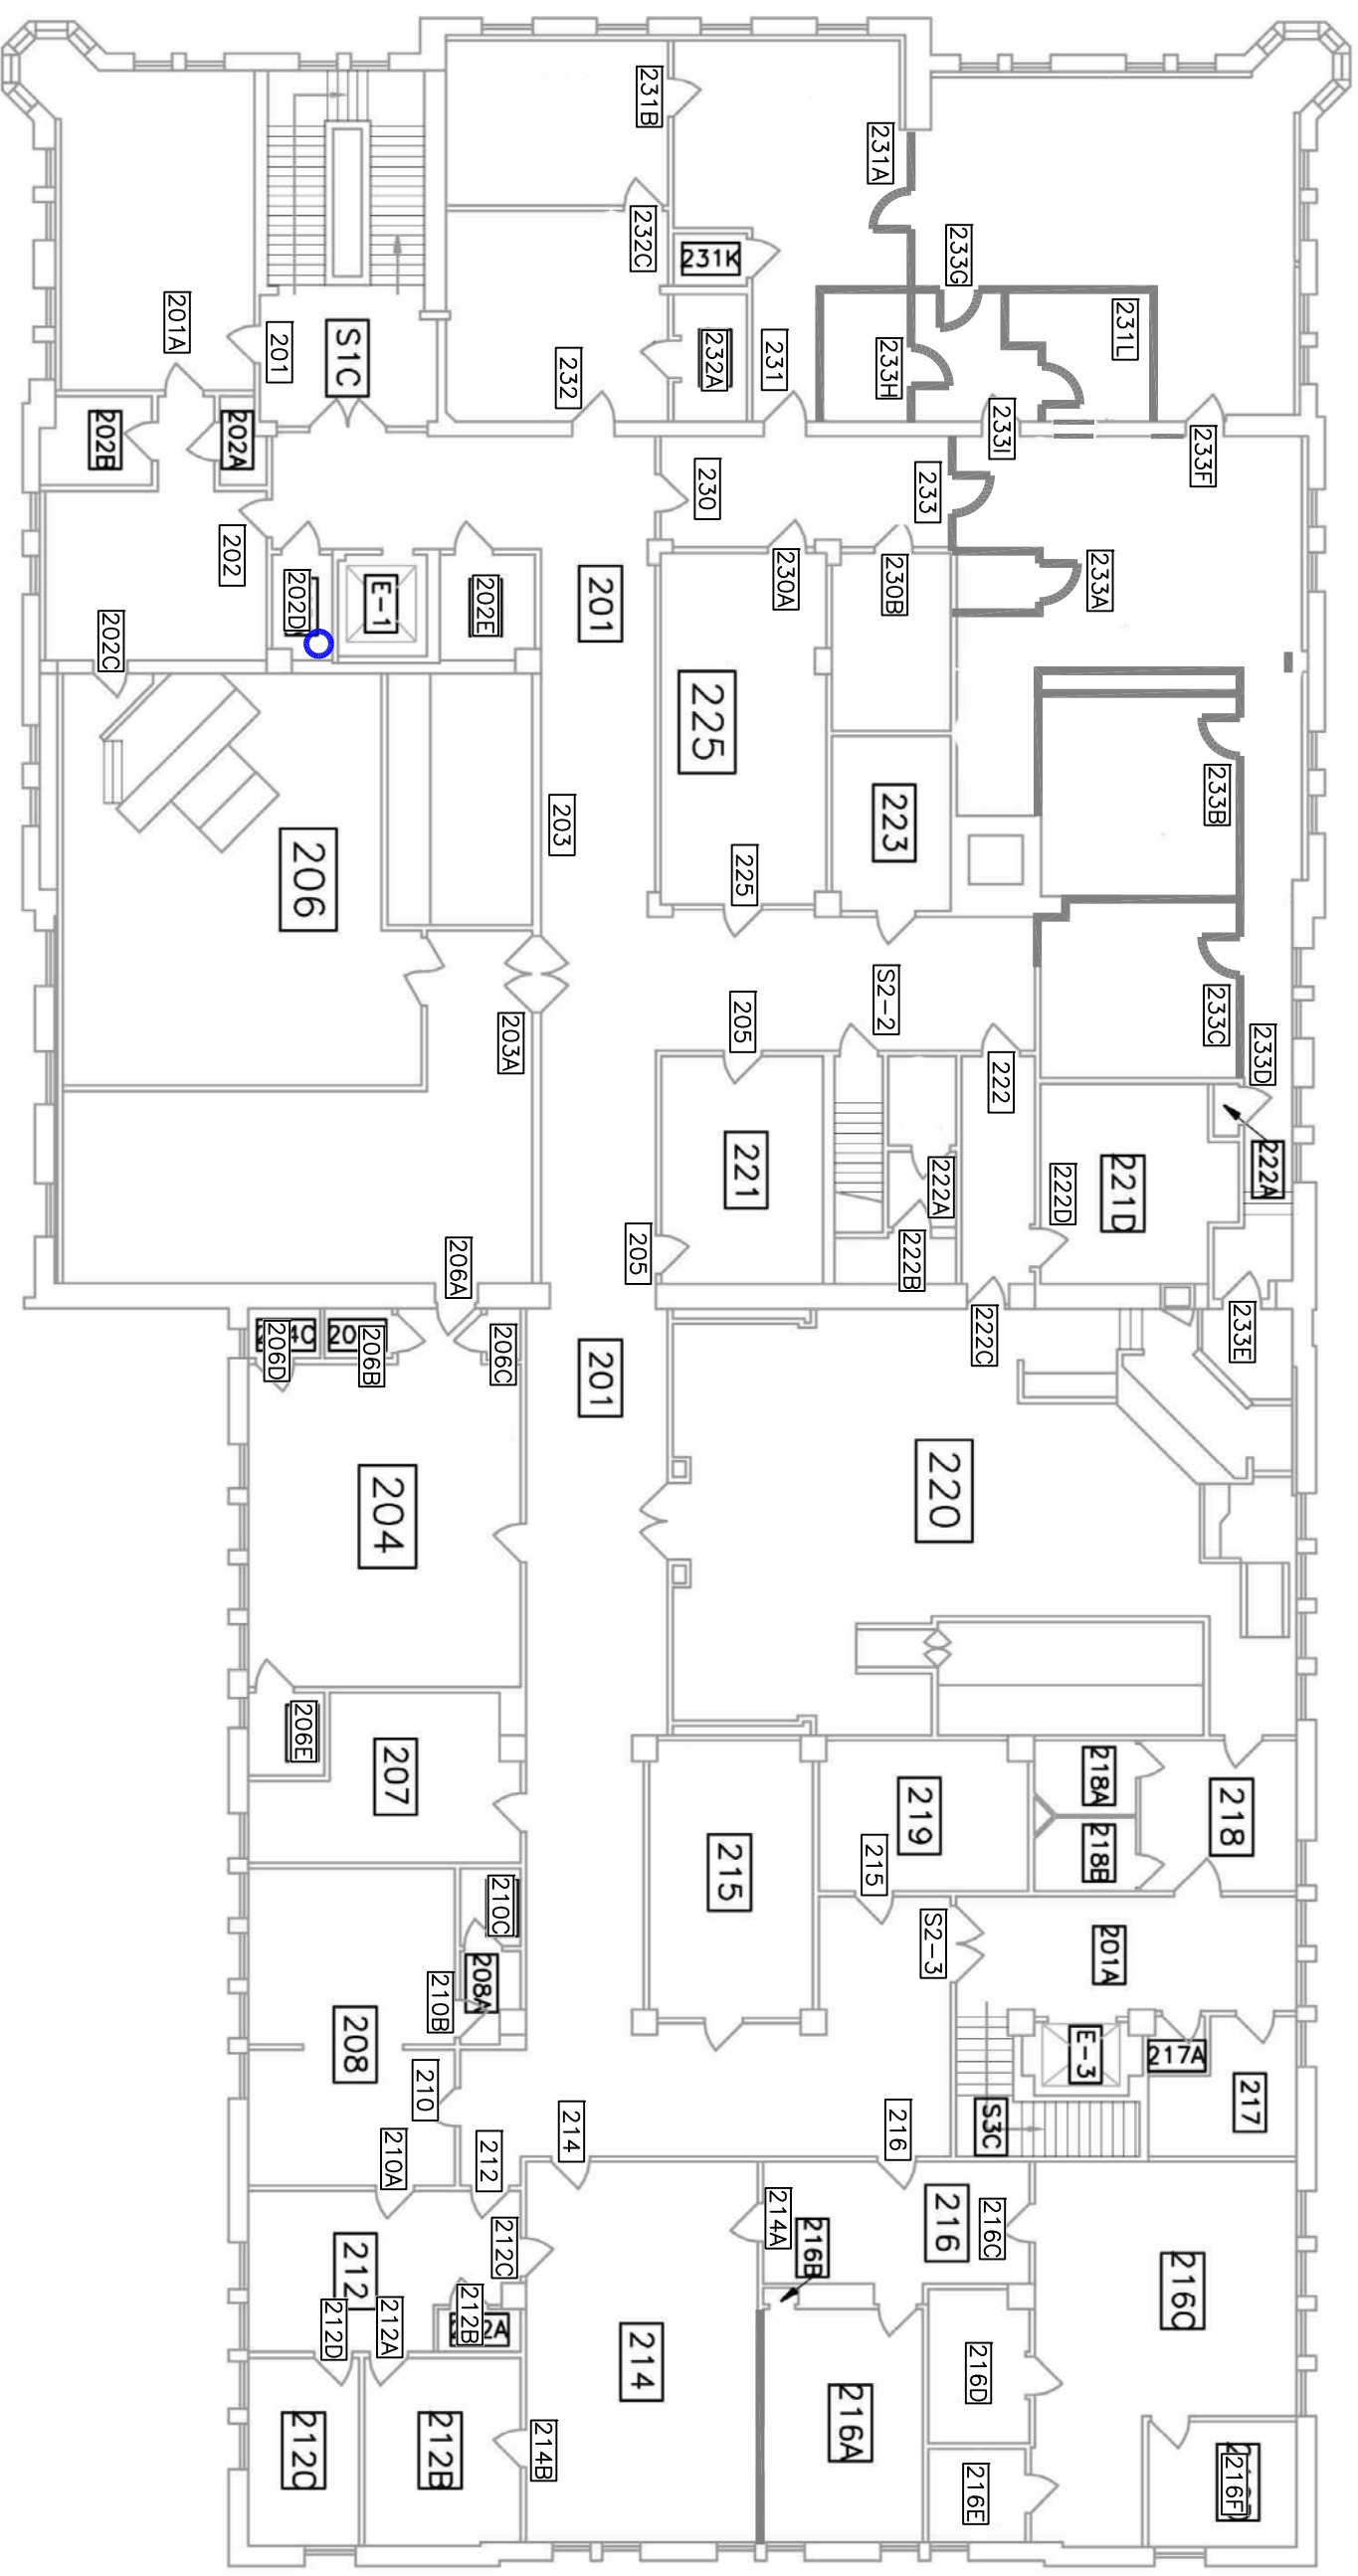
ACBM THERMAL SYSTEM INSULATION LOCATIONS

- 203 Room Number
- ACM Mudded Fittings on Vent Lines. *(T2.7)
- ACM Hard Straight Run on Abandoned Heating Pipes. *(T3.7)

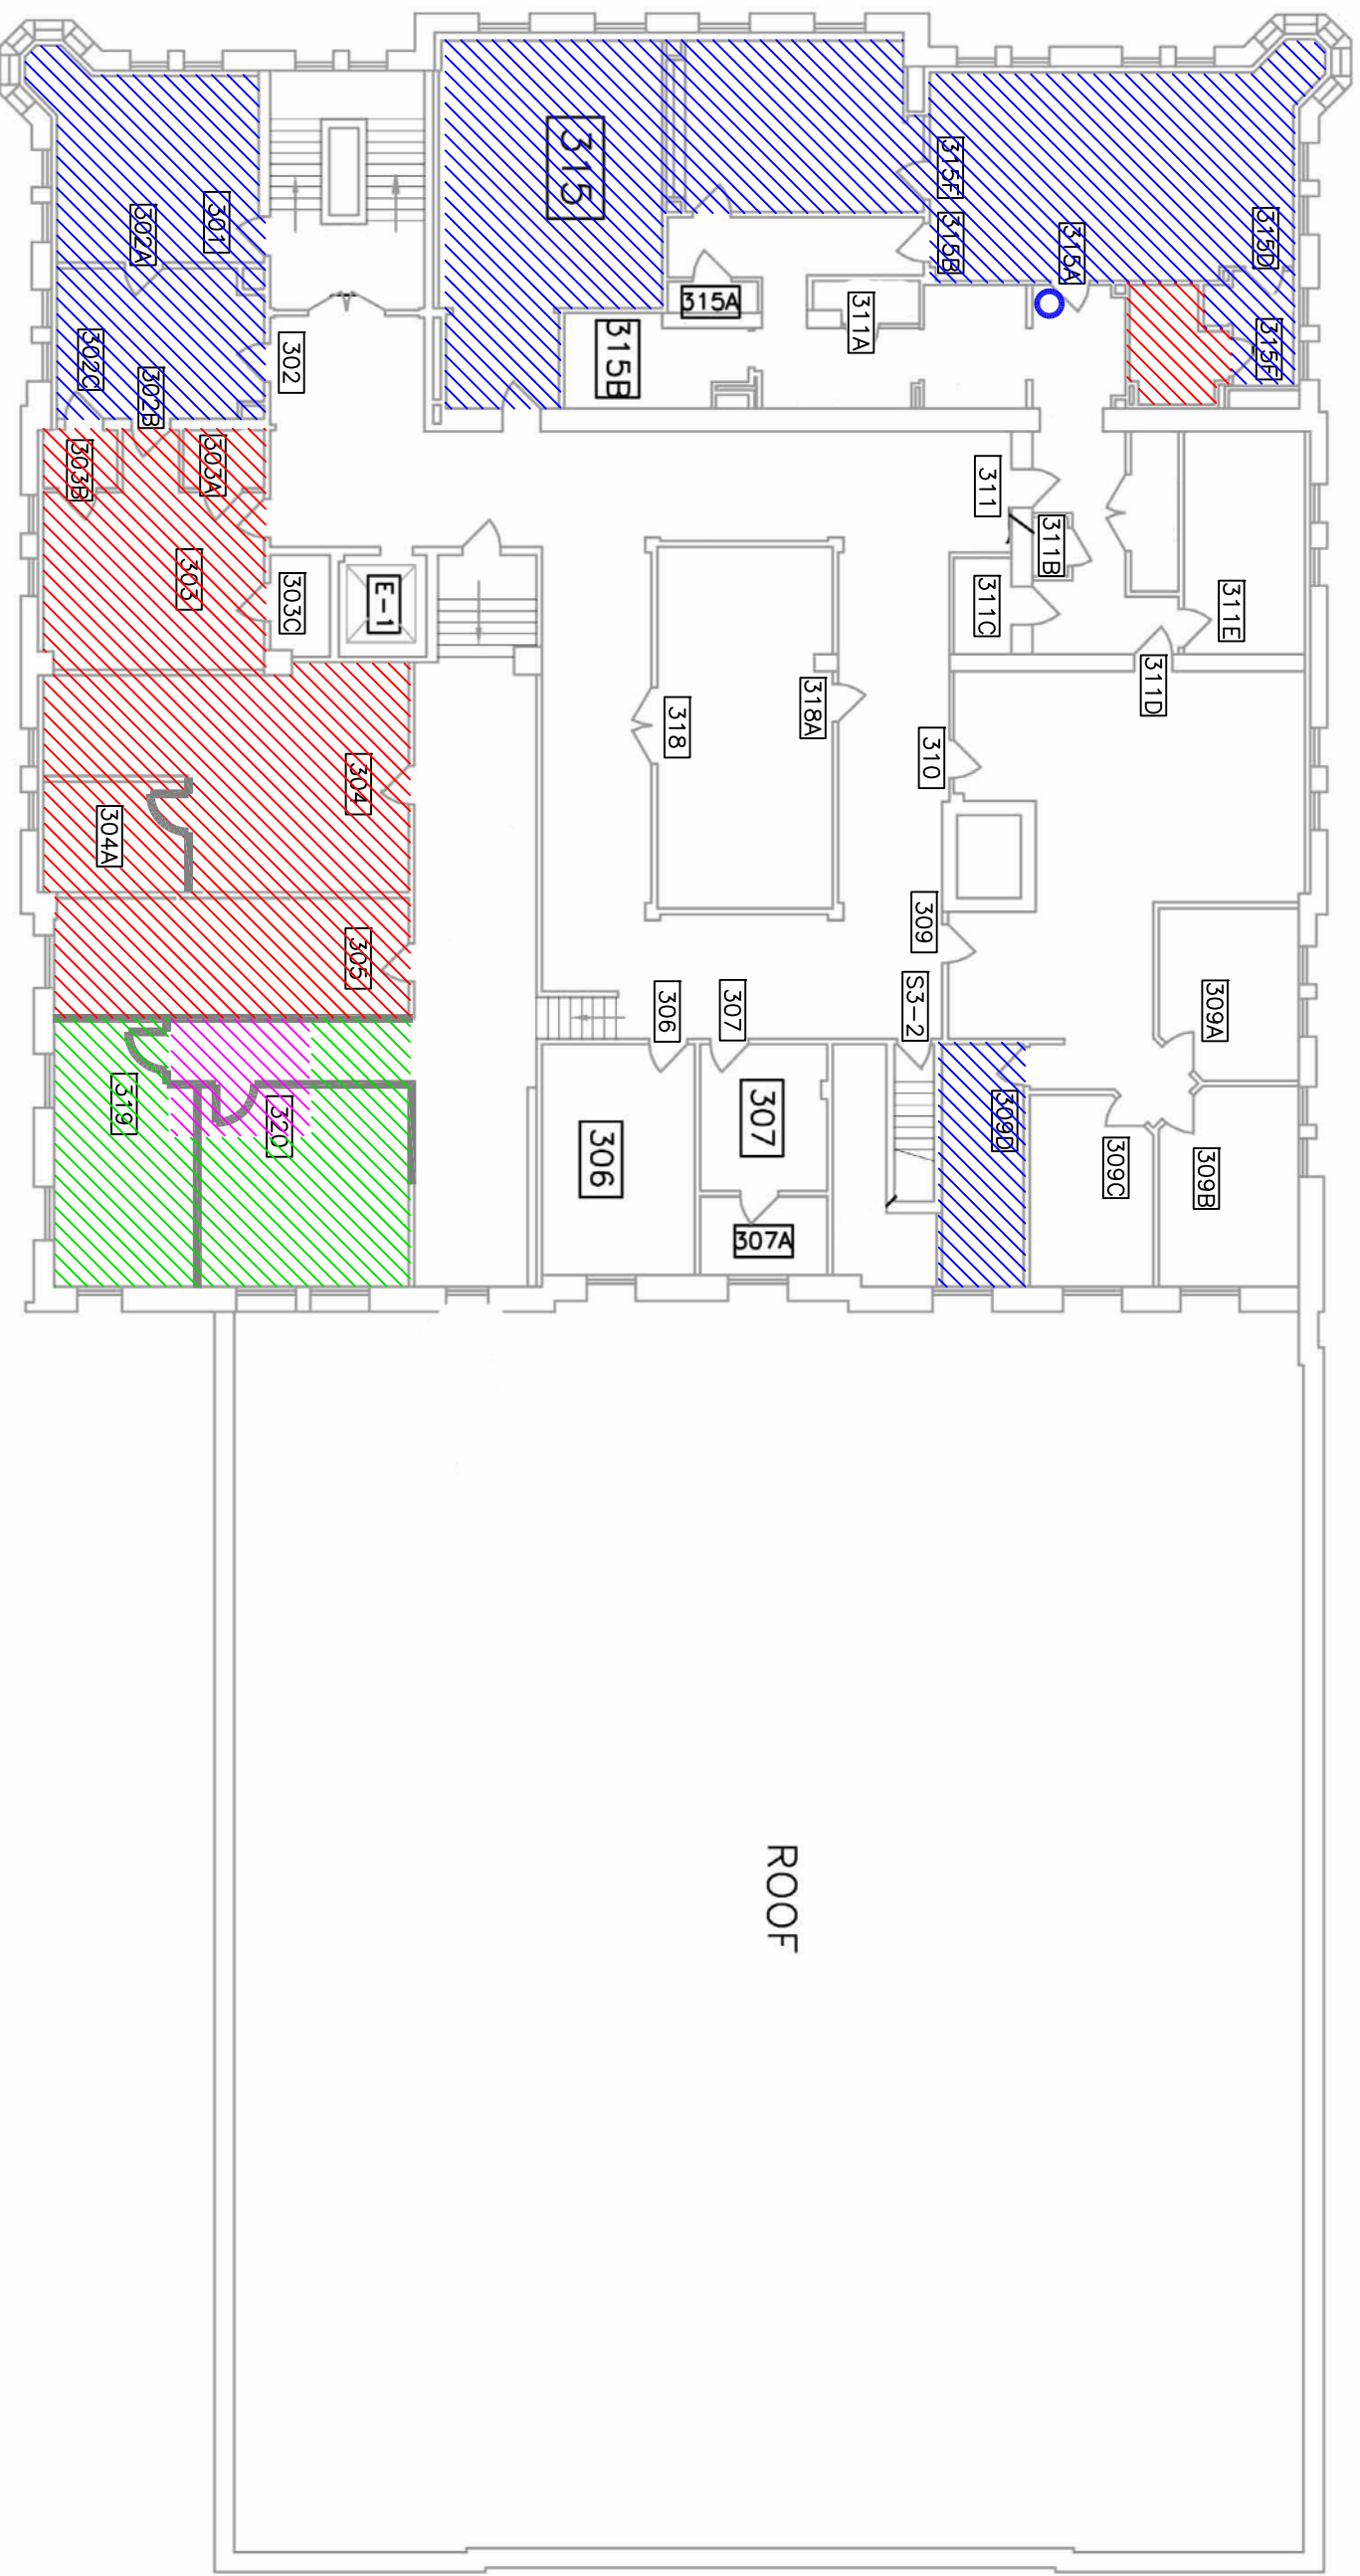
ACBM FLOORING AND MISCELLANEOUS MATERIAL LOCATIONS

| | Room Number | | ACM - 12"x12" Floor Tile *(F2.8) |

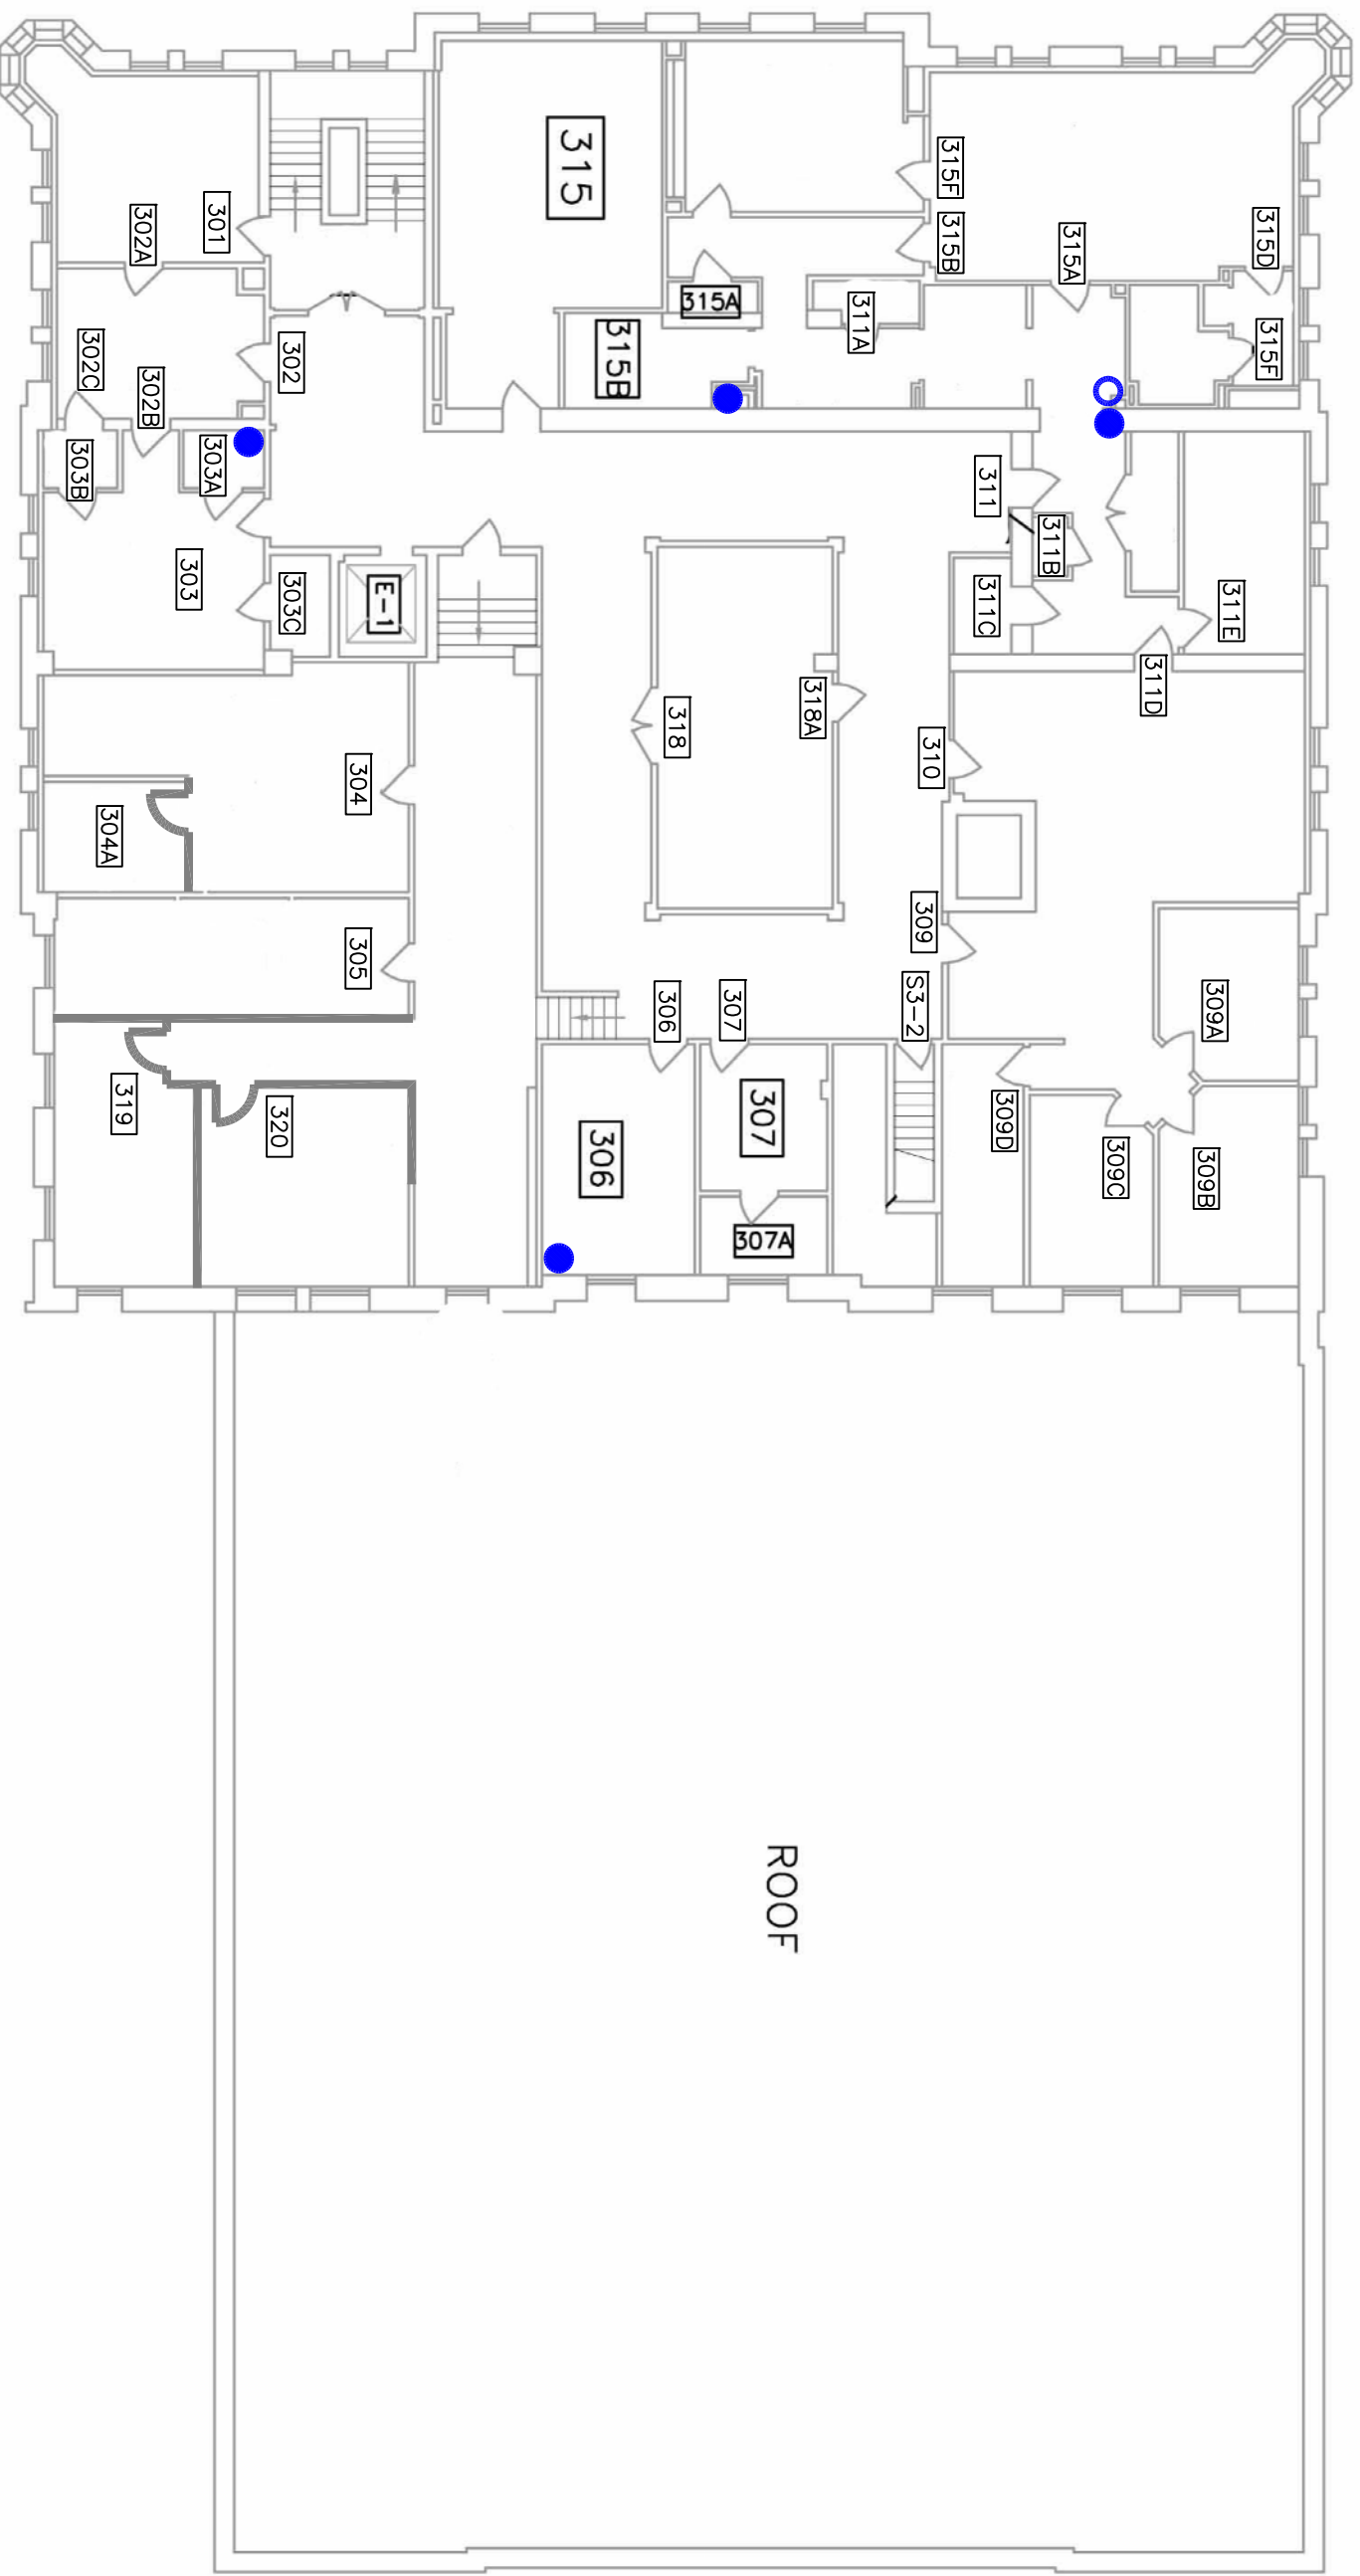
Figure A-12
Date: February 21, 2014

- LEGEND**
- 319 Room Number
 - ACM Mudded Fittings on Vent Lines. *(T2.7)
 - ACM Hard Straight Run on Abandoned Heating Pipes. *(T3.7)
