HAZARDOUS BUILDING MATERIALS INSPECTION REPORT

Sioux Falls VA Medical Center

**New SPS Addition
Sioux Falls, South Dakota**

VA Project No: 438-460

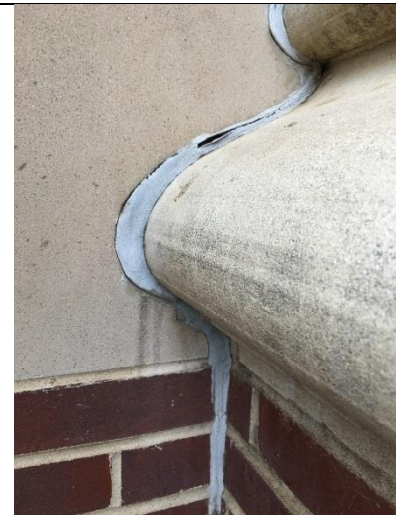
PHOTO 14 Gray Joint Caulk - Exterior

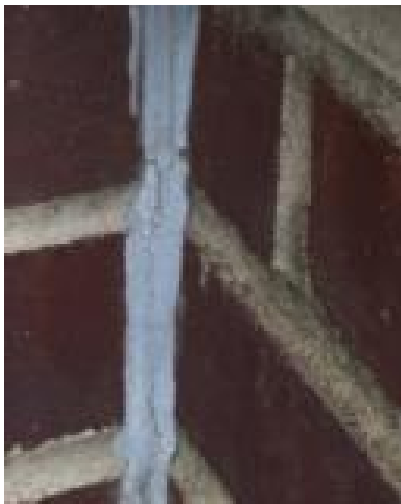
PHOTO 15 Gray Joint Caulk - Exterior

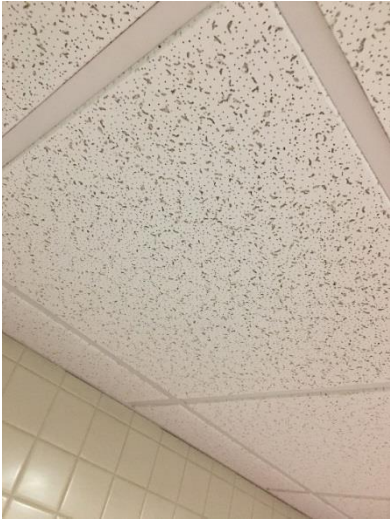
PHOTO 19 | 2' x 2' Ceiling Tile D-17

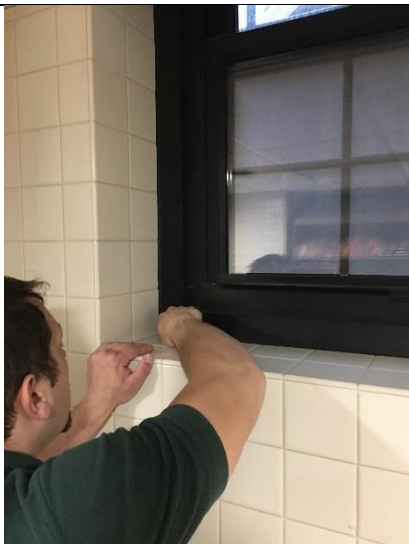
PHOTO 23 | Black Window Caulk – Windows Throughout

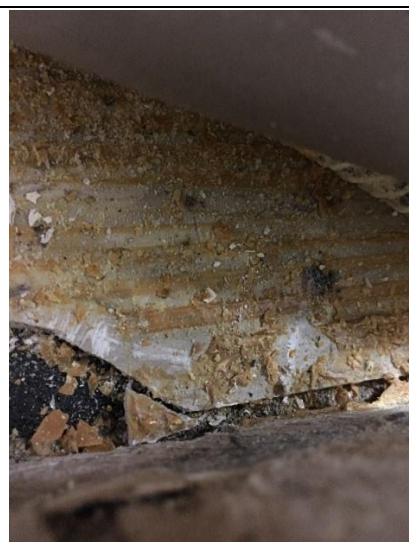
PHOTO 30 | Beige VFT Black Mastic (under carpet) – D 21

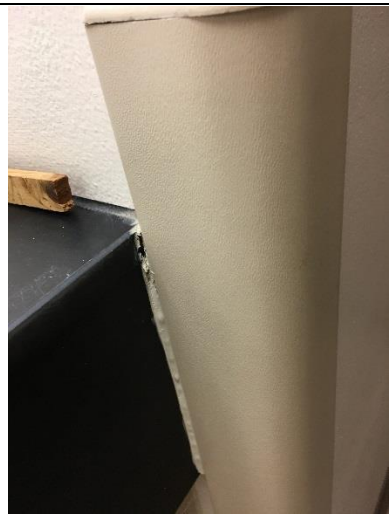
PHOTO 36 White Mastic – Lab Base Cabinets

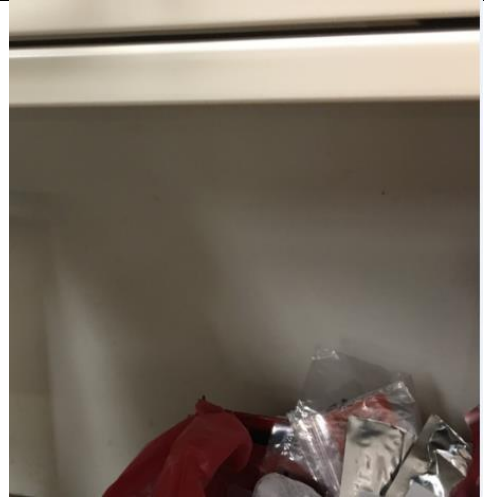
PHOTO 38 Plaster Wall – Lab (Exterior Wall)

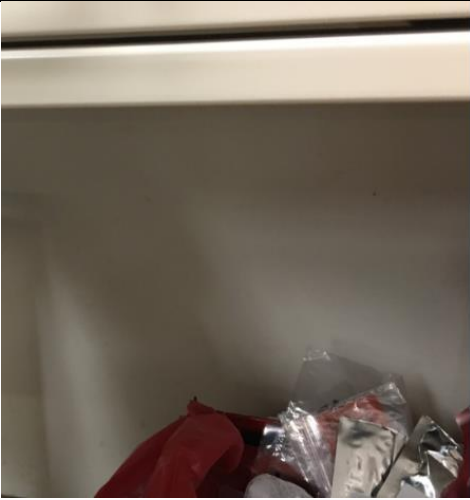
PHOTO 39 Plaster Wall – Lab (Exterior Wall)

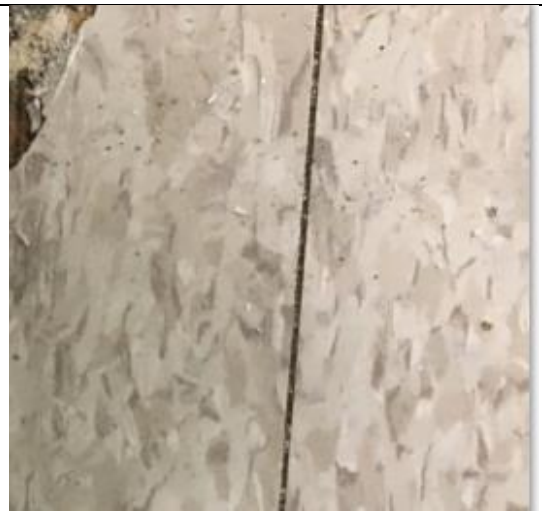
PHOTO 42 12" x 12" VFT Tan Blotchy/Mastic
Black Mastic 4% Chrysotile

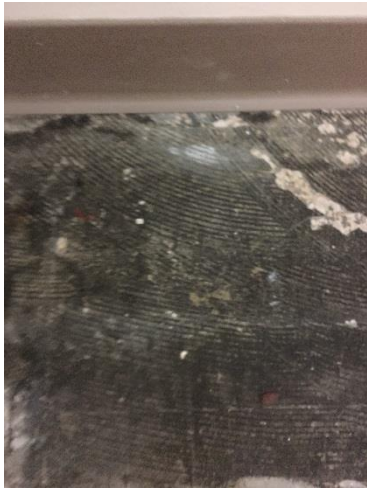
PHOTO 43 Black Mastic – D-20
5% Chrysotile

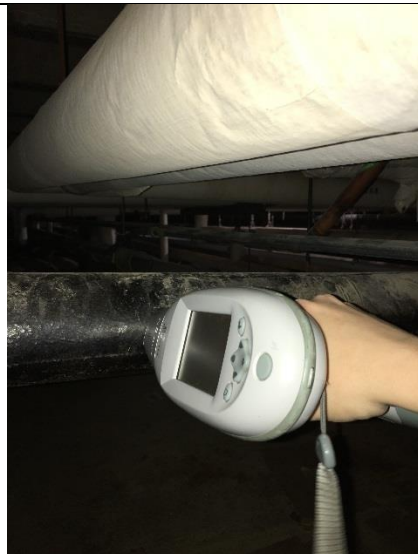
PHOTO 35 Black Pipe – Tunnel
<1mg/cm² lead

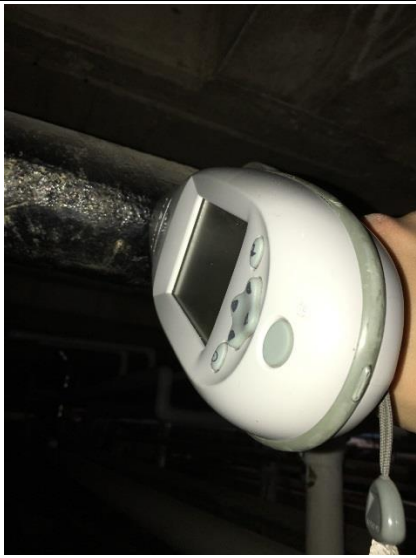
PHOTO 36 Black Pipe – Tunnel
<1mg/cm² lead

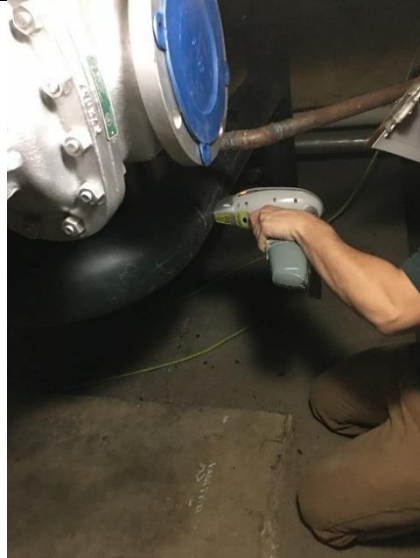
PHOTO 37 Black Pipe – Tunnel
<1mg/cm² lead

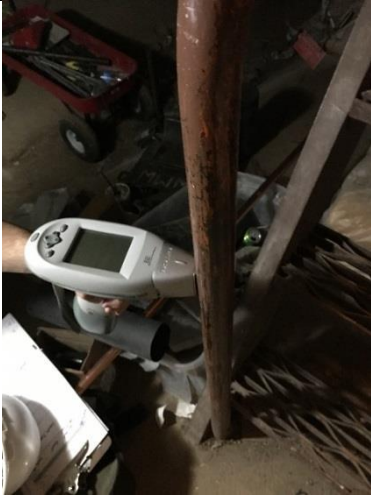
PHOTO 38 Black Pipe – Tunnel
<1mg/cm² lead

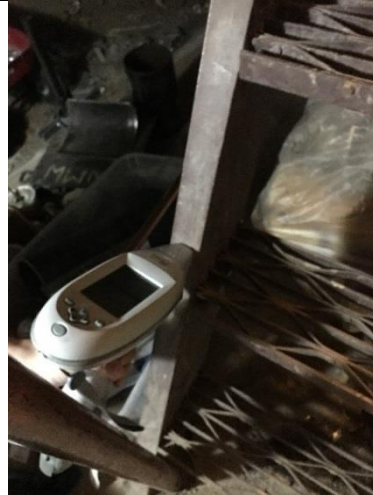
PHOTO 39 Brown Hand Railing-Stairs to Tunnel
3.8 mg/cm² lead

Based on the initial lead paint testing results, AMIE recommends TCLP testing be conducted on the existing building materials, painted and unpainted, prior to the start of renovation or demolition activity. In addition, trade contractors who work in the facility should also be notified of the presence of lead so that they can appropriately monitor and protect their workers against lead exposure.

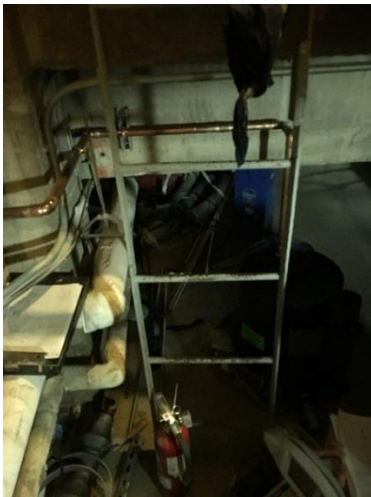
PHOTO 40 Brown Stairs to Tunnel
2.9 mg/cm² lead

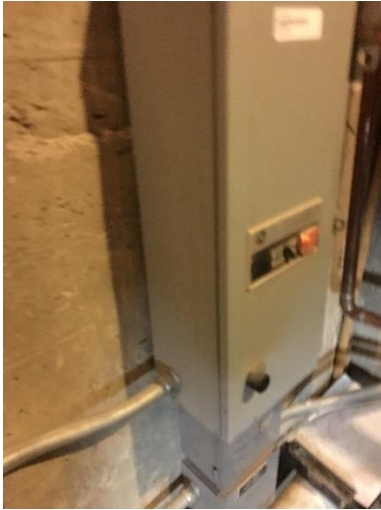
PHOTO 42 Silver Valve - Tunnel
<1mg/cm² lead

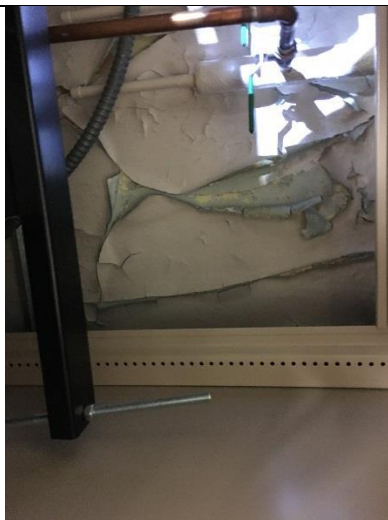
PHOTO 74 Black Metal surrounding sink basin
<1mg/cm² lead

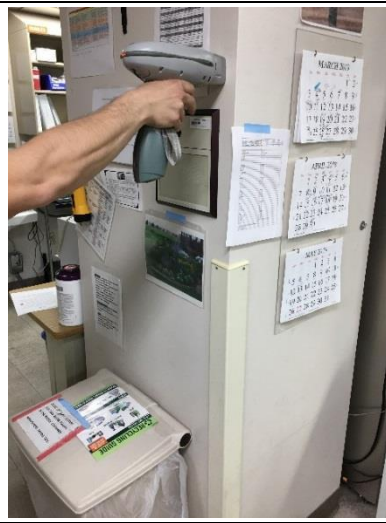
PHOTO 77 White Paint on Sheetrock - Lab
<1mg/cm² lead

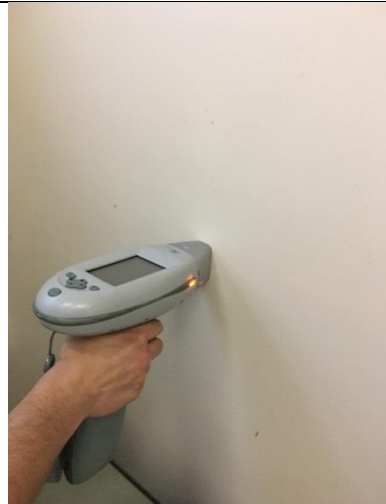
PHOTO 81 East Wall - D-20
<1mg/cm² lead
