HAZARDOUS BUILDING MATERIALS INSPECTION REPORT

Sioux Falls VA Medical Center

**New SPS Addition
Sioux Falls, South Dakota**

VA Project No: 438-460

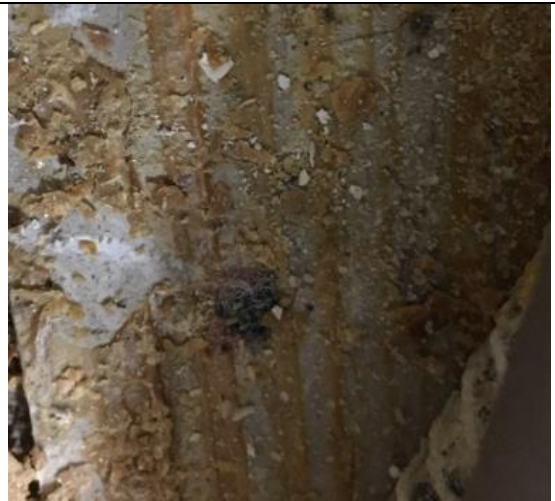
PHOTO 28 | Brown Carpet Mastic – D 21

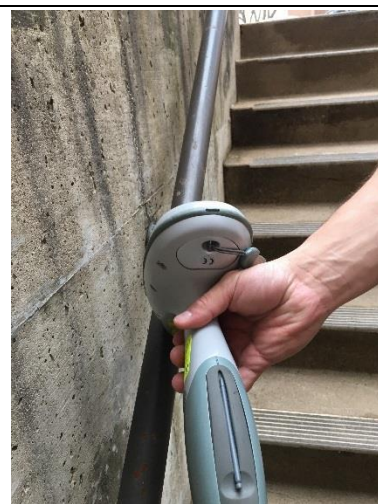
PHOTO 24 Brown Hand Railing-Stairs to Mech. Room
1.7 mg/cm² lead

Based on the initial lead paint testing results, AMIE recommends TCLP testing be conducted on the existing building materials, painted and unpainted, prior to the start of renovation or demolition activity. In addition, trade contractors who work in the facility should also be notified of the presence of lead so that they can appropriately monitor and protect their workers against lead exposure.

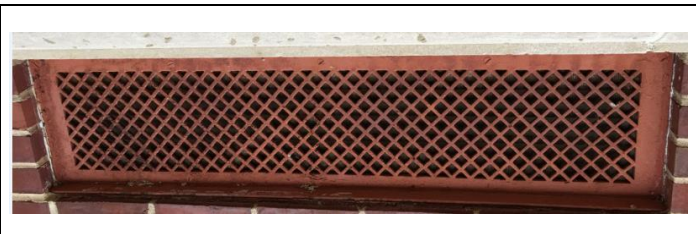
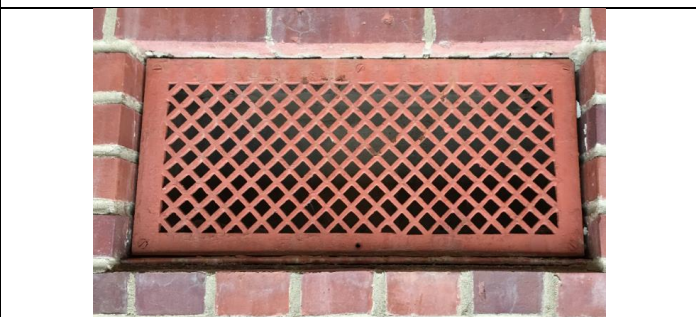
PHOTO 29 Red Decorative Grate on vertical wall - exterior
10.2 mg/cm² lead

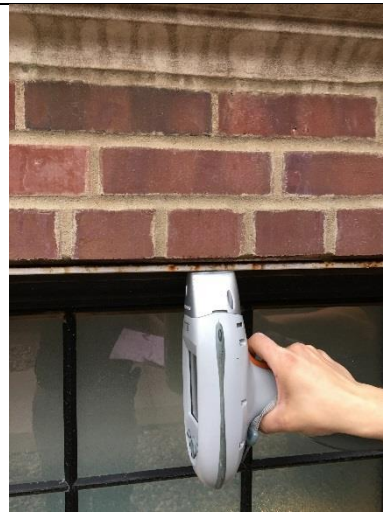
PHOTO 32 White Top Plate – Exterior Window
15 mg/cm² lead

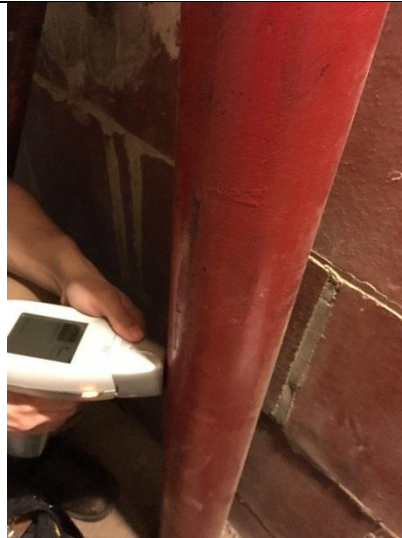
PHOTO 43 Wall in Hallway Tower 3
<1mg/cm² lead

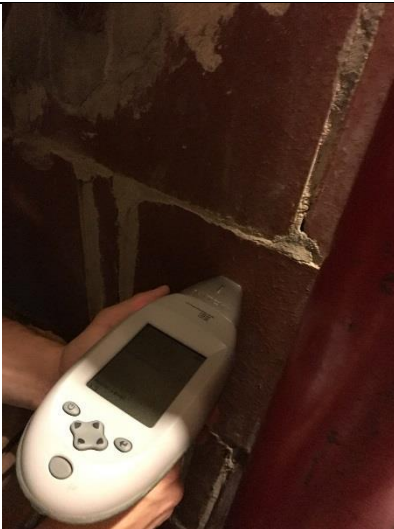
PHOTO 44 Wall in Rm.360 East Pipechase Tower 3
<1mg/cm² lead

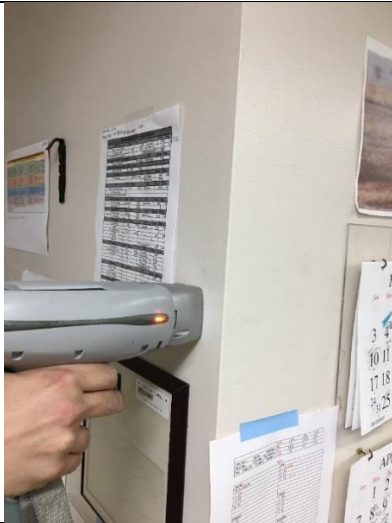
PHOTO 76 White Paint on Plaster
<1mg/cm² lead
